# Spartan Fire, LLC

Campaign Service Bulletin  
CSB22-250-001A

**CONDITION:** Front Suspension could experience a loss of dampening due to lower shock eye position.

**CORRECTION:** Replace lower shock mount and bolt.

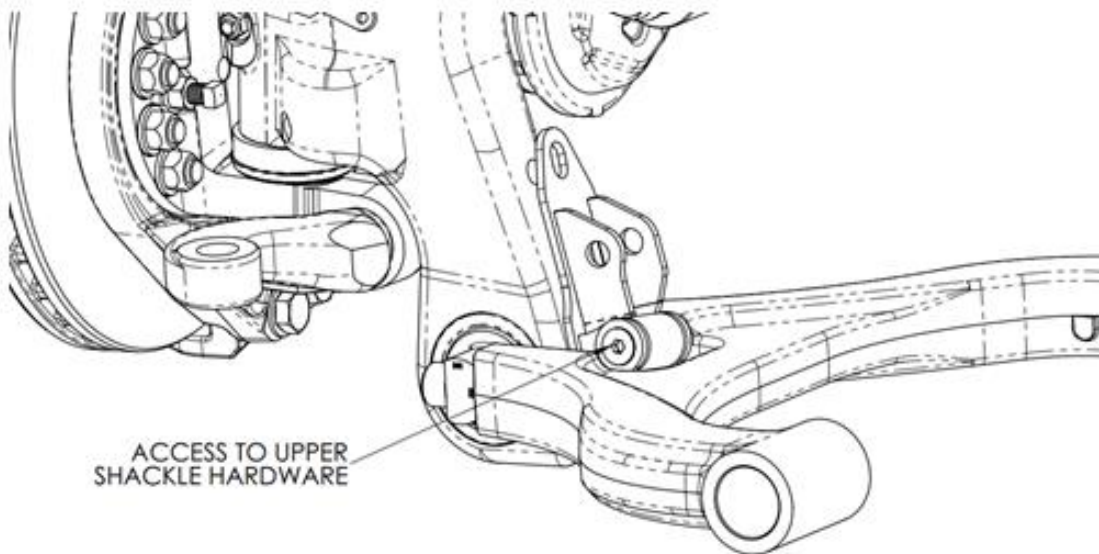
### 24k Tips and Tricks (cont.):

At full suspension droop, the lower shock bracket can be rotated about the one difficult to access bottom flathead screw if the other two fasteners are removed. This rotation often allows enough displacement of the bracket to allow access to the upper shackle bolt. Loosening the upper shackle bolt allows the shackle links to be swung out of the way and
