INFINITI®

CAMPAIGN BULLETIN Fan Coupling Nut Torque Inspection

Reference: P3A06

P3A06 – 2023 QX80 COOLING FAN COUPLING NUTS

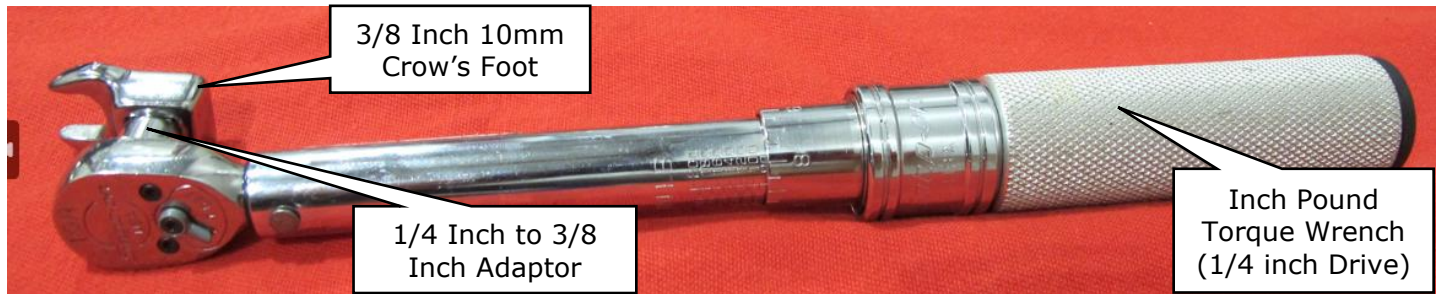
TOOL REQUIREMENT:

- Use the torque wrench set-up shown in Figure 1
- Fan coupling nut torque is 9.0 N•m (0.92 kg-m, **80 in lb**)

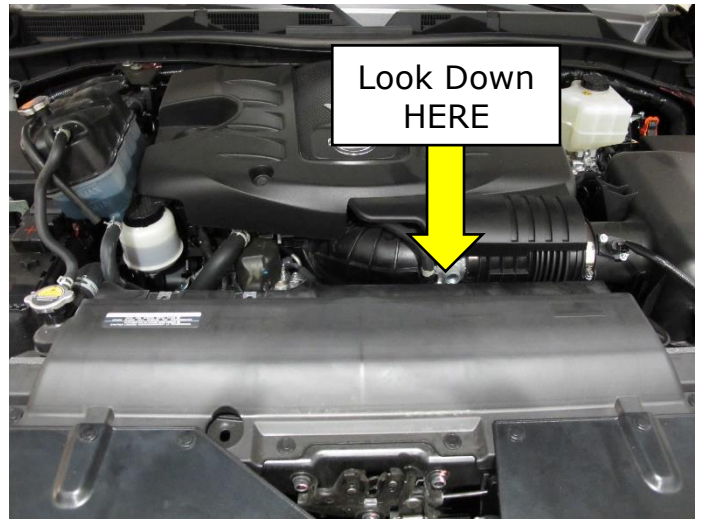
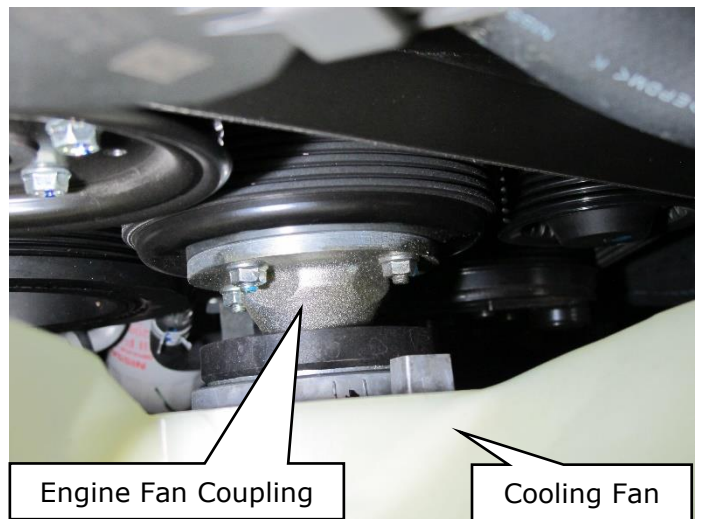
4. Look down at front of the engine and locate the engine fan coupling (Figures 5 and 6).

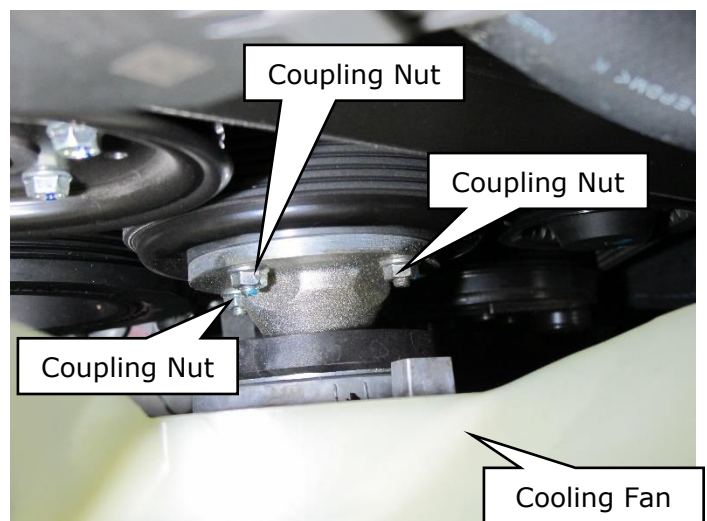
Figure 9

NOTE: The bottom fan coupling nut is not shown in Figure 9.

7. Locate the (4) fan coupling nuts.

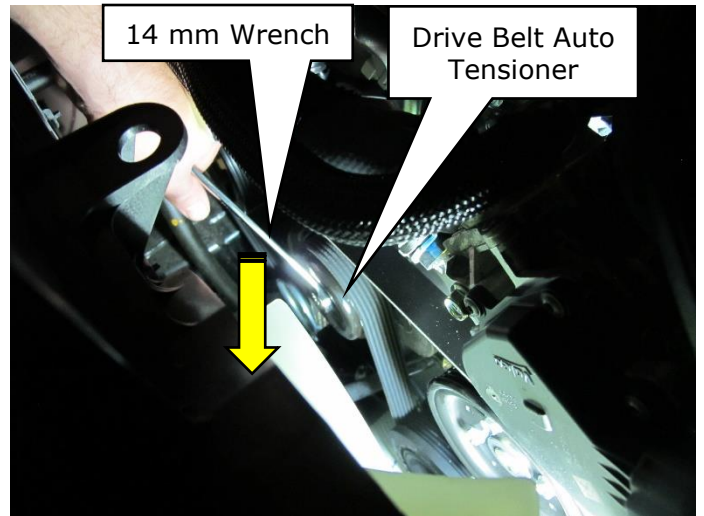
Figure 12

- **Never place hand in a location where pinching may occur if the wrench accidentally falls off.**
- **Never loosen the hexagonal part in the center of the auto tensioner pulley (Never turn it clockwise). If turned clockwise, the complete auto tensioner must be replaced as a unit, including the pulley.**

10. Turn the fan pulley to reach the remaining fan coupling nut(s) to be torqued.

- Install a 14mm wrench on the drive belt auto tensioner, push down on the wrench to release belt tension (Figure 12)
- With belt tension released, turn the fan clutch pulley to gain access to the remaining nut(s)
