Service Bulletin

Bulletin No.: 23-NA-062

Subject: Rear View Camera Issues – DTCs B395A, B395B, B395C, B101E, B101D

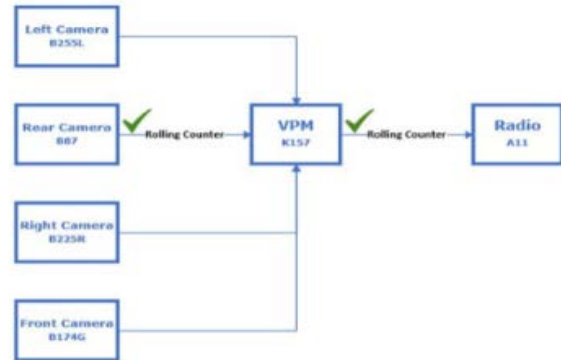
6083545

The Radio requires a rolling counter to ensure a video output on the radio screen. This counter prevents a frozen image to be displayed to the vehicle owner when shifting into Reverse.

This rolling counter is monitored continuously to ensure we have video signal from the rear camera. It goes from the rear camera to the VPM and from the VPM to the radio.

If the rear camera or the VPM do not provide the rolling counter, you will see the following black screen with an icon:
