TECHNICAL INSTRUCTIONS
FOR
CUSTOMER SUPPORT PROGRAM 22TE09
HV FLOOR UNDER WIRE HARNESS AND REAR TRACTION MOTOR CABLE
CORROSION
CERTAIN 2020 –2022 MODEL YEAR HIGHLANDER HYBRID AWD

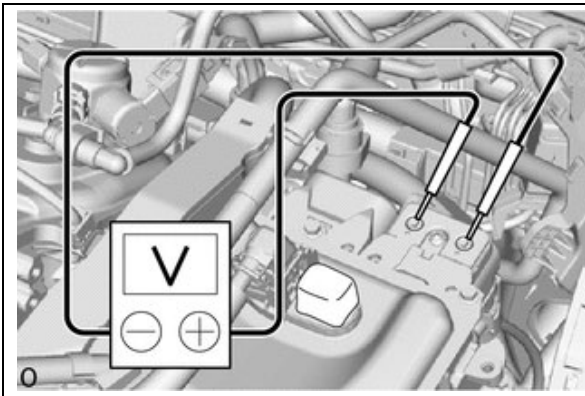
- Using a voltmeter, measure the voltage between the terminals of the 2 phase connectors.

Standard Voltage: 0 V
