GROUP	MODEL
BOD	2022-2023MY Telluride (ON)
NUMBER	DATE
318	June 2023

TECHNICAL SERVICE BULLETIN

SUBJECT: **REAR HVAC CONTROL CLIP REPLACEMENT (SA534)**

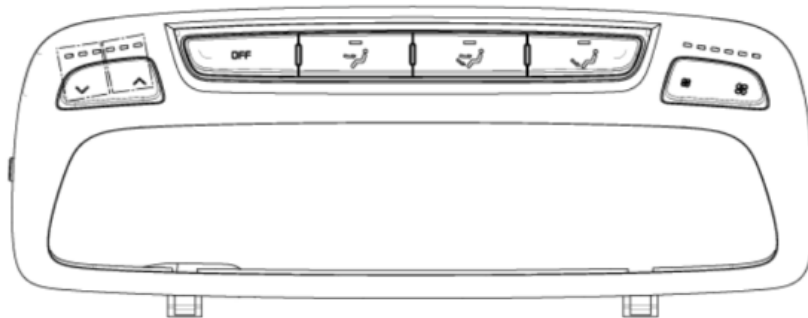
This bulletin provides information to replace the rear Heating Ventilation and Air Condition (HVAC) control assembly retaining clips on some 2022-2023MY Telluride (ON) vehicles produced from August 1, 2022 through May 03, 2023. The affected vehicles are equipped with a metal retaining clip which can create a rattling sound while driving on rougher road conditions. New plastic retaining clips will be installed to help rectify this rattling noise concern. Follow the procedure outlined in this publication to replace the HVAC control assembly retaining clips. Before conducting the procedure, verify that the vehicle is included in the list of affected VINs.
