GROUP	MODEL
BOD	2023MY Telluride (ON)
NUMBER	DATE
320	June 2023

## TECHNICAL SERVICE BULLETIN

SUBJECT: **FRONT DRIVER DOOR BELT OUTSIDE  
WEATHERSTRIP INSPECTION/REPLACEMENT (SA535)**

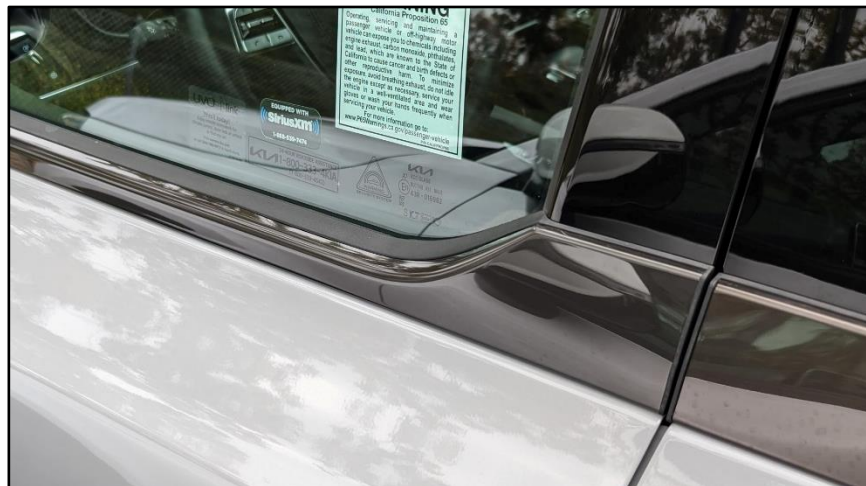
This bulletin provides information to inspect front driver door belt outside weatherstrip on some 2023MY Telluride (ON) vehicles produced from March 13, 2023 through June 6, 2023. The affected vehicles may be missing an adhesive layer causing the outer faceplate to detach/separate from the molding. Follow the procedure outlined in this publication to inspect and, if necessary, replace the driver front door belt outside weatherstrip. Before conducting the procedure, verify that the vehicle is included in the list of affected VINs.
