Technical Service Bulletin

GROUP CAMPAIGN	NUMBER 23-01-039H
DATE JUNE 2023	MODEL(S) Ioniq 5 Electric (NE1)

SUBJECT: VCU UPDATE AND OWNER'S MANUAL SUPPLEMENT (CAMPAIGN TAF)

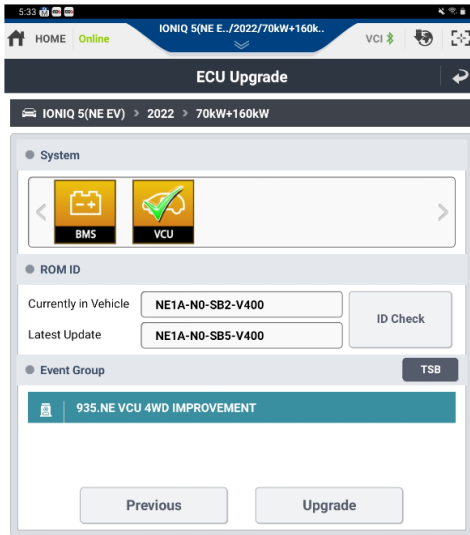
GDS Vehicle Battery Voltage:

- This VCU Update is long, so the 12V battery must be at good charge level (>60% SOC).
- If the voltage is below 12 volts as per the GDS warning, then select **Back** and run the vehicle at least 30 minutes to reach an adequate battery state of charge to prevent an ECU Update failure. Cycle the ignition **OFF/ON** before retrying ECU update again.
