SERVICE BULLETIN

APPLICABILITY: 2022-23MY BRZ Models **NUMBER:** 15-297-22R
SUBJECT: Reprogramming File Availability for Optimization of Gen 4 Denso CP1 Infotainment Systems **DATE:** 07/01/22
REVISED: 06/30/23

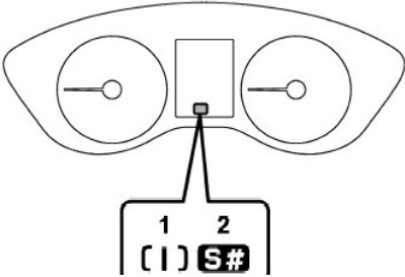
Number	Symptoms to be Improved:
16	Message reading function of short mail does not resume and ends once it is interrupted by barge-in voices for other functions.
17	<p>After the Ignition Switch is turned on, the SI-DRIVE indicator starts blinking and the derive mode cannot be changed.</p>

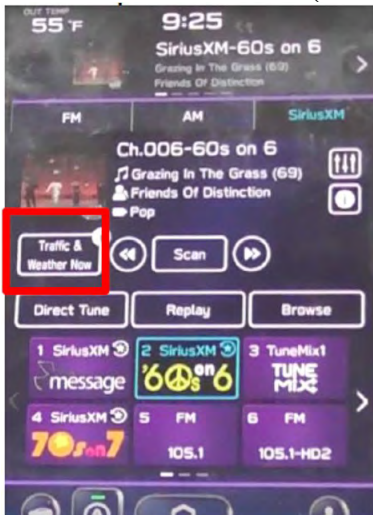
23	Soon after the cable has been removed from the AUX TERMINAL (USB Hub), icons on Home Screen stop functioning.
24	Phone Book is displayed in the order of the First Name even though the display setting was made in the order of Family Name.
25	<p>No response when touching "Traffic & Weather Now (TWN)" on SMX screen.</p>
