SERVICE INFORMATION BULLETIN

APPLICABILITY: 2019-22MY Ascent
 2020-22MY Legacy & Outback 2.4L

NUMBER: 02-190-22R

SUBJECT: Proper Diagnosis of Oil Level Switch Leaks

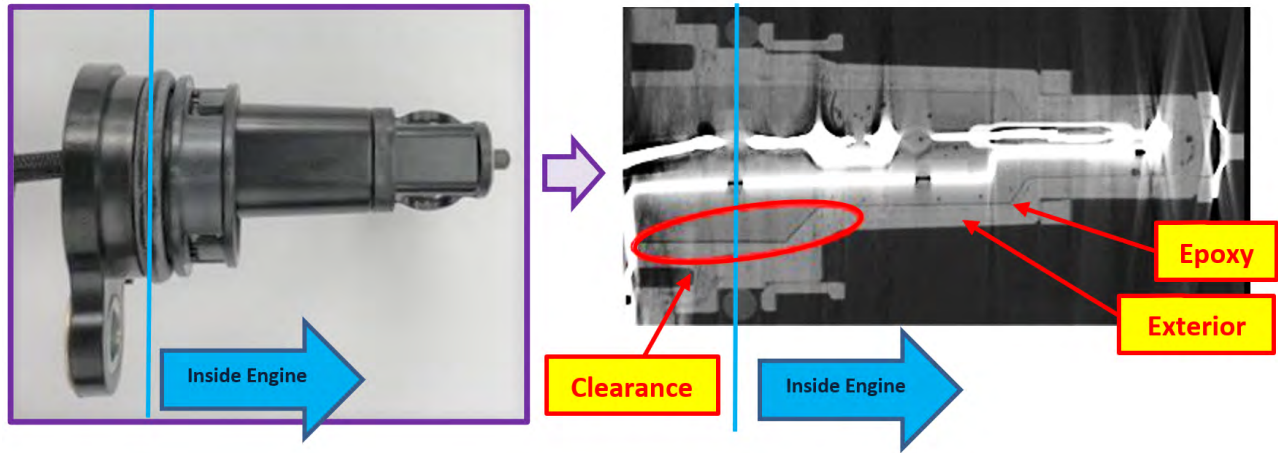
Please follow the procedure below if you find any engine oil on the level switch when an oil leak is being detected. First clean the area and apply a leak seeking powder for easier observation.

1. Observe contact surfaces of the following:
2. Oil Level Switch, Lower Oil Pan, Upper Oil Pan, Engine Block, Cylinder Heads, and Transmission.
3. Confirm if engine oil is leaking from anywhere other than the oil level switch.
4. If any leaks are found, drain the engine oil, and replace and/or reseal the leaking part(s) as necessary.
5. When replacing the leaking component, take special care not to damage the oil level switch by contacting it with other parts while removing and installing, as the float may become damaged. As for the oil level switch, if there's no cracks or damage found during visual inspection, clean and reinstall the switch.
6. Correct the engine oil level. Perform a road test. Re-inspect for any leaks.

IMPORTANT: The oil level switch o-ring is a one time use part and should be replaced when the switch is removed, replaced, or when the upper oil pan is resealed.
