WRINKLES ON LEATHER SEAT SURFACE OF NEW (UNSOLD) VEHICLE

Bulletin No.: 09-007/23

Last Issued : 06/01/2023

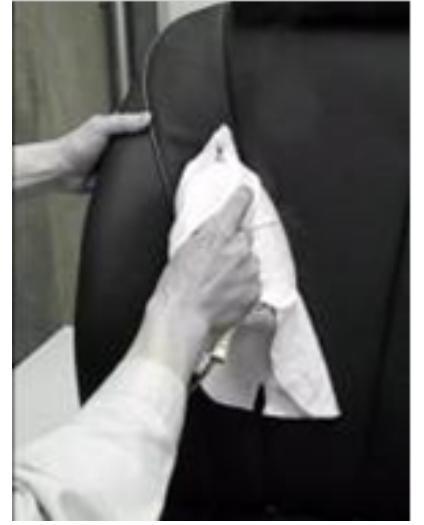
NOTE: Always keep the cloth wet. Spray water on the cloth repeatedly before it dries.

- 3. Wrap the bottom of iron by the water-soaked cloth.
- 4. Stretch the wrinkled portion of seat surface by hand.
- 5. Run the iron with the cloth on the wrinkled area, as shown below.
