# Service Alert

<b>Subject:</b>  <b>CONNECTED VEHICLE SYMPTOM TROUBLESHOOTING</b>	<b>Service Alert No.:</b> SA-009/23
	<b>Last Issued :</b> 06/12/2023

2019-2023 Mazda3  
2020-2023 CX-30  
2021-2023 CX-5  
2021-2023 CX-9  
2022-2023 MX-30  
2023 CX-50  
2024 CX-90

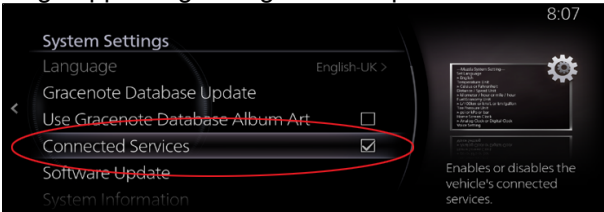
<p>Connected Services disabled (box unchecked)</p>

<p>Enable Connected Services (box checked) to prevent message appearing at engine start up.</p>

<p><b>Note:</b> If customer Opted-Out ( <a href="#">CSP04</a> ), advise customer to keep Connected Services box checked. The vehicle will not transmit data.</p>
<p>Connected Vehicle Maintenance Mode</p>

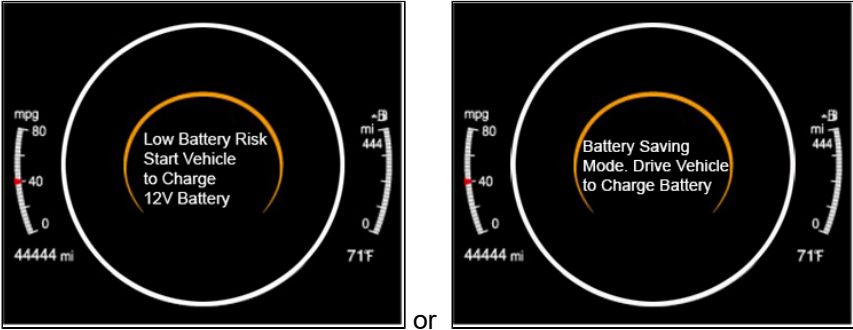
**Remote Engine Start Will Not Function under the following conditions**

Item	Condition
1	Vehicle battery voltage low
2	Automatic Transmission shift position except "P"
3	Vehicles equipped with manual transmission
4	Vehicle speed above 3 mi/h (5 km/h)
5	Brake pedal switch malfunction
6	Engine has been running by remote engine start function
7	Engine started by remote engine start more than 2 consecutive times while the vehicle is not driven. The vehicle must be driven 1-mile or 24-hours must pass from the last successful Remote Engine Start for the use count to reset.
8	2021 Mazda3, 2021 CX-30, CX-50, MX-30: Vehicle's electrical control area network (CAN) is in "Sleep Mode"

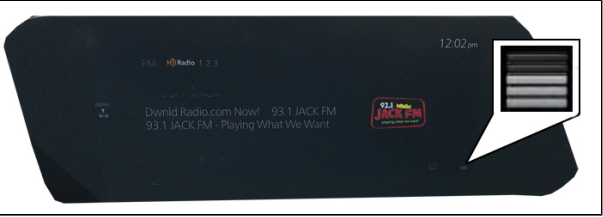
<p>Infotainment Center Display</p>	<p><b>TCU Active</b></p>	<p><b>Reception Icon Shows normal strength</b></p>

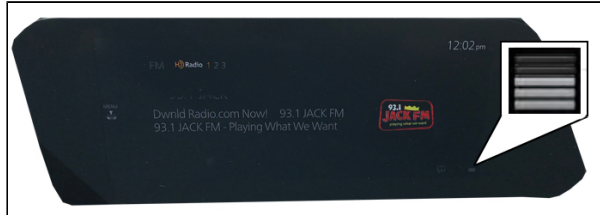
- If the reception icon shows "X", the vehicle is possibly in Deactivation Mode.

- Customer/Dealer can activate CV services anytime via MyMazda app (there just might be a slight delay in making the backend connection since it was temporarily deactivated).
- If the reception is weak, move the vehicle to a location where the reception is good to strong as shown in the table, then try to get the Authorization Code and/or operate the remote functions before proceeding to the Repair Procedure if there is still an issue.
- If the reception is good to strong, proceed to Connected Vehicle Troubleshooting below.

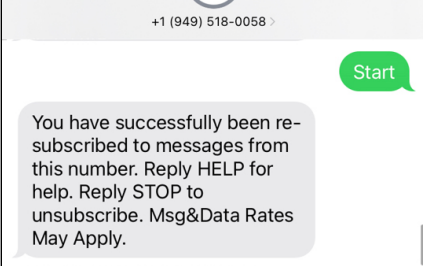
Connected Vehicle Troubleshooting		
Symptom	Cause	Action
<p>The customer is not able to create a MyMazda account. The customer receives the following error:</p> <p><b>MyMazda App</b> - Internal Usher SDK error.</p>

<p><b>MyMazda Website</b> - ERROR! Unable to send one-time password.</p>	<p>Customer inadvertently texted <b>“Stop”</b> to 1-949 518-0058 (Twilio SMS for Mazda)</p>	<ol style="list-style-type: none"> <li>Text <b>“Start”</b> to 1-949 518-0058 (Twilio SMS for Mazda)</li> <li>Retry to create a MyMazda account.</li> </ol> <p><b>NOTE:</b> USA and Canada only</p>

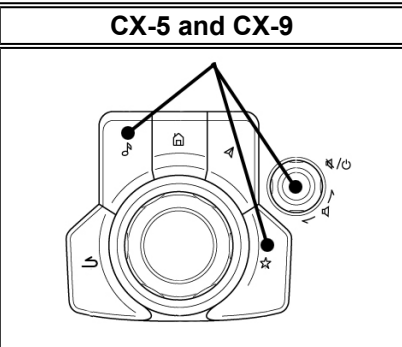
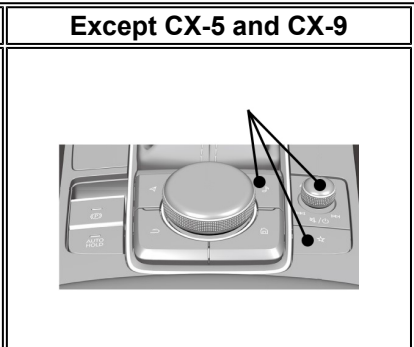
1. Press and hold the Volume knob, then press and hold the Entertainment and Favorite buttons at the same time for 3-5 seconds and the Factory/Service Inspection screen will appear.

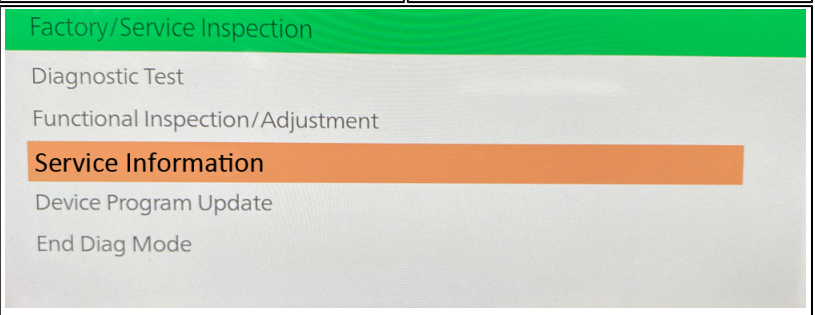
2. Select Service Information.

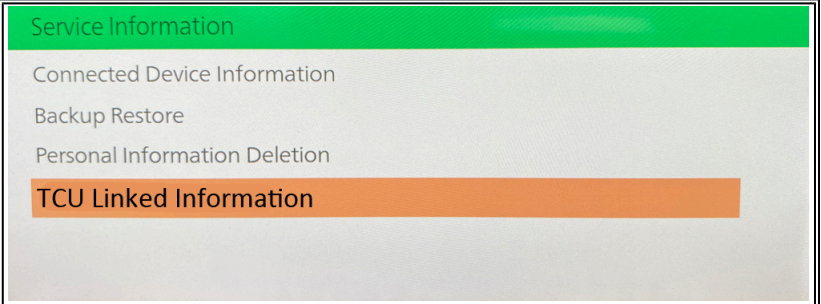
3. Select TCU Linked information.
