RSB-56-23-002-1: R1S Upper Liftgate Body Fit and/or Water Leakage

Document Type	Technical Service Bulletin
Date	June 14, 2023
Affected Region(s)	USA
Affected Model(s)	R1S
Model Year(s)	2022
Approximate Build Dates	November 2021 - July 2022

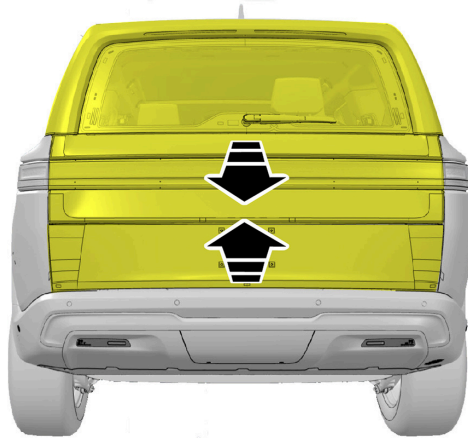
1.

c. The upper liftgate is aligned within specification if the narrow side slides freely in the gap and the wide side does not fit in the gap.

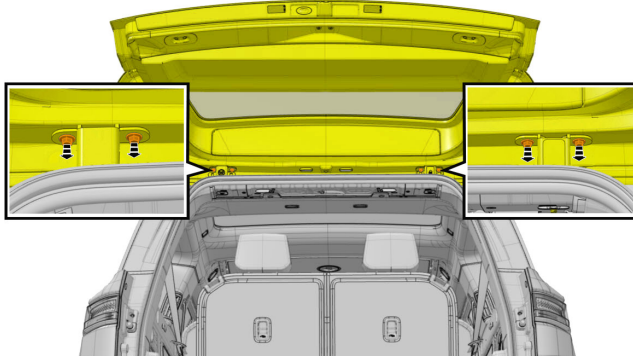
1.

a. Check the gaps shown.

- 2-6 mm with upper liftgate assist struts installed
- 3.5-7.5 mm with upper liftgate assist struts removed

b. If adjustment is necessary: Loosen the highlighted fasteners to adjust the component.

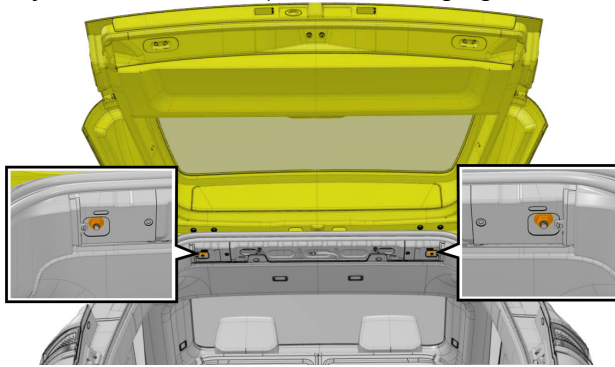
2.

a. On both sides: Check the gaps shown.

Target gap: Defined by the special tools in the [Inspection](#) section.

b. If adjustment is necessary: Loosen the highlighted fasteners to adjust the component.

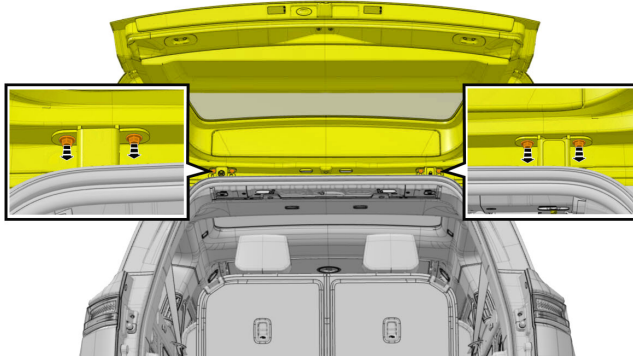
3.

a. Check the gaps shown.

Target gap: Equal values (the component should be centered).

b. If adjustment is necessary: Loosen the highlighted fasteners to adjust the component.

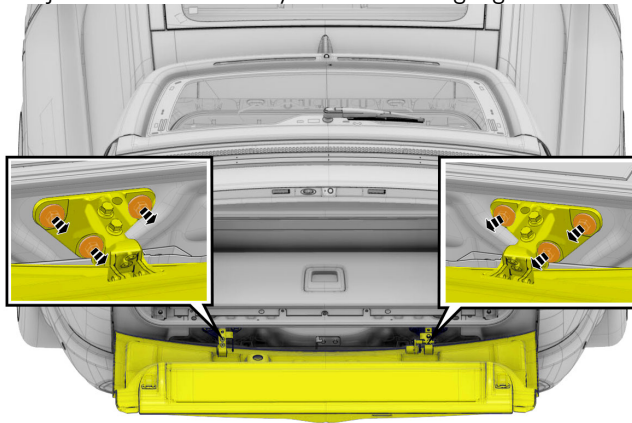
4.

a. Check the gaps shown.

1	2.3-5.7 mm
2	3.1-8.9 mm

b. If adjustment is necessary: Loosen the highlighted fasteners to adjust the component.

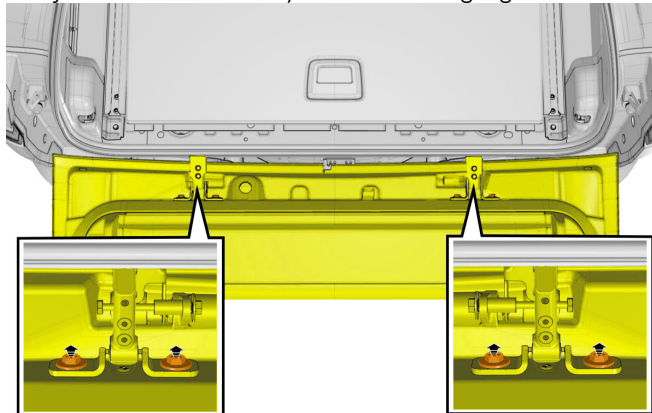
Target gap: Equal values (the component should be centered).

- c. If adjustment is necessary: Loosen the highlighted fasteners to adjust the component.

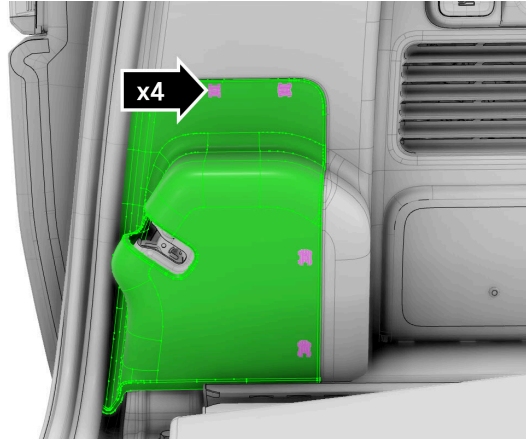
Target flushness: Lower liftgate 0.5-3.5 mm underflush to the body side.

- b. If adjustment is necessary: On both sides: Use a trim tool to pry near the highlighted clip(s).

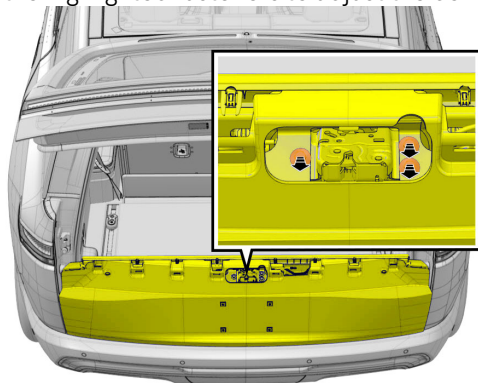
7.

- a. On both sides: Check the flushness between the components.

- b. If adjustment is necessary: Remove: Trim Panel, Lower Liftgate, Upper (refer to service manual procedure 641956010).

- c. Loosen the highlighted fasteners to adjust the component.
