Service Bulletin

Bulletin No.: 23-NA-042

Subject: Radio Software Version V164 Update

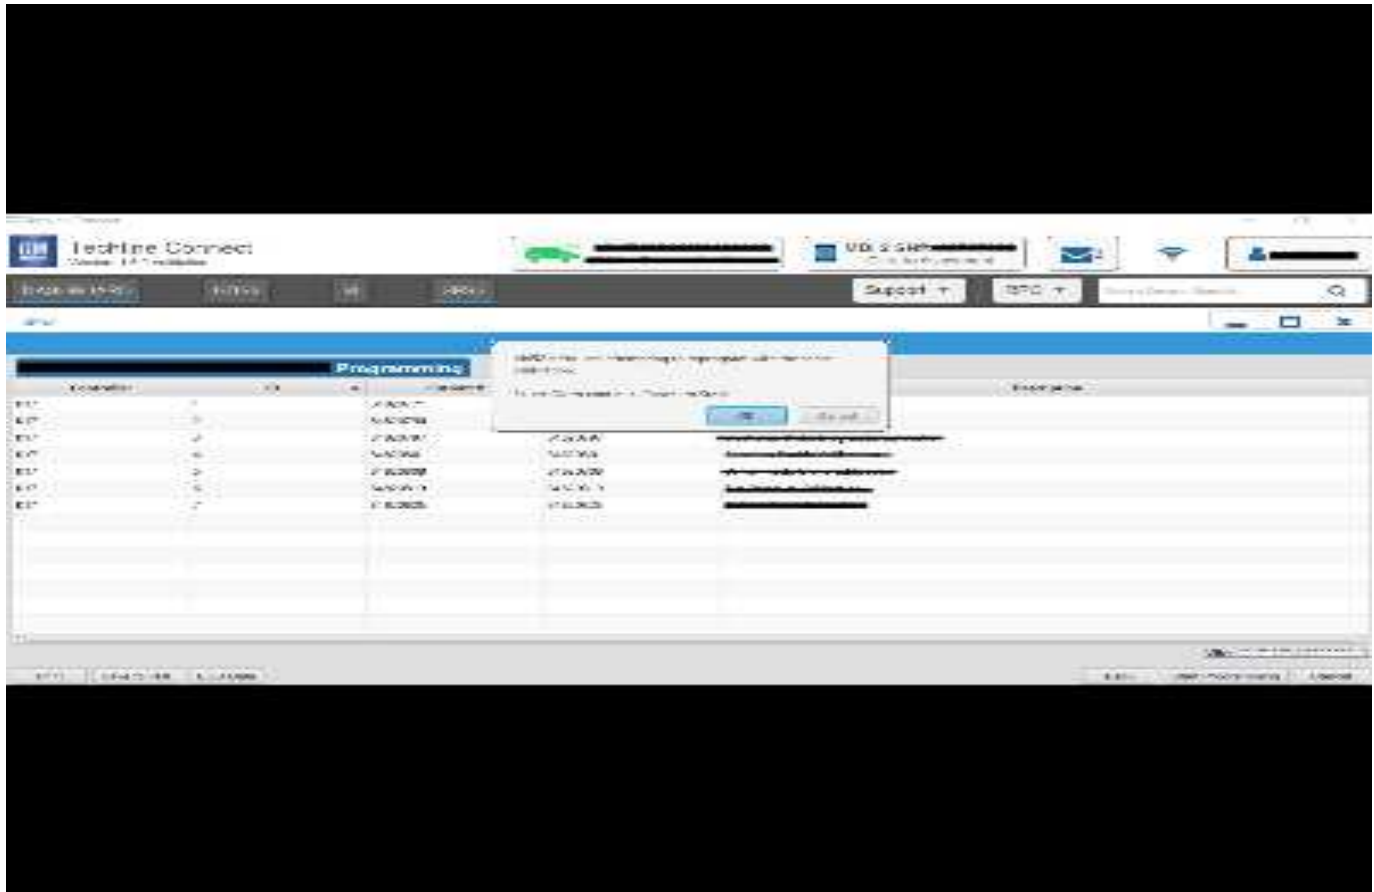
5644477

Important: Techline Connect screen shown above.

Important: If the same calibration/software warning is noted on the TLC Summary screen, select OK and follow screen instructions. After a successful programming event, the WCC is located in the Service Programming System dialogue box of the SPS
