Bulletin No.: PIP5926

PIP5926 Transmission Fluid Leak Between the Transmission and Transfer Case

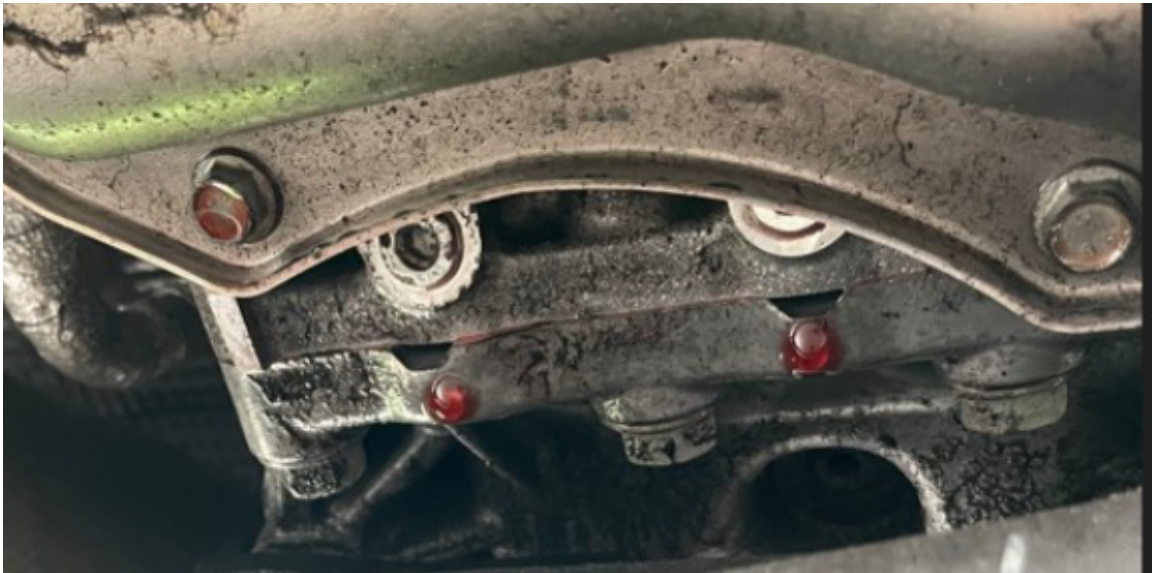
Involved Region or Country	North America, Middle East, Israel and Australia/New Zealand.
Additional RPO	NQF NQH
Condition	Some customers or technicians may comment of a transmission fluid leak between the transmission and transfer case.
Cause	The Transmission Case Extension Seal (call out 1 second pic below) is leaking or the Transfer Case Input Shaft Seal (call out 1 third pic below).

Note: The cavity between the Transmission and Transfer Case is a wet cavity by design. The Transfer Case Input Shaft Seal is a double seal to prevent fluid transmission and transfer case fluid from intermixing with each. If either side of the seal leaks fluid will leak from the weep holes between the Transmission and Transfer Case.

Adding dye to either the transfer case or transmission will help determine if the seal depth is incorrect.

If the seal is installed to deep the fluid leaking is transmission fluid.

If the seal is not installed deep enough the fluid leaking is transfer case fluid.

Either condition will cause fluid to leak out of the weep holes between the transmission and transfer case.

Replace the Transmission Case Extension Seal (call out 1 second pic below) and Transfer Case Input Shaft Seal (call out 1 third pic below).
