GLOBAL SAFETY FIELD INVESTIGATIONS
DCS6626
URGENT - DISTRIBUTE IMMEDIATELY

Subject: N222383020 - Service Update
ECM Does Not Properly Report CVN to Service Tools

Models: 2022 Chevrolet Silverado 1500 New
2022 GMC Sierra 1500 New

N222383020 ECM Does Not Properly Report CVN to Service Tools

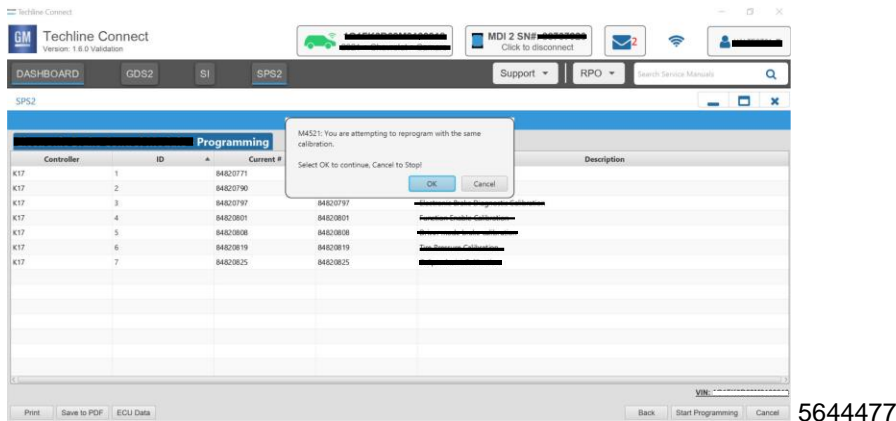
Important: Techline Connect screens shown above.

Important: If the same calibration/software warning is noted on the TLC Summary screen, select OK and follow screen instructions. After a successful programming event, the WCC is located in the Service Programming System dialogue box of the SPS Summary screen. No further action is required. Refer to the Warranty section of the bulletin.
