# **Service Bulletin**

## Subject: Information on Spark EV (BEV) High Voltage Battery Exchange Process

# This bulletin replaces PIP5112S to reflect the revised TAC approval and battery pack ordering process. Please discard PIP5112S.

Brand:	Model:	Model Year:		VIN:		Engine	Electric
		from	to	from	to	Engine:	Drive Unit:
Chevrolet	Spark EV	2014	2016	All	All	EN0	1ET35 (RPO MME)

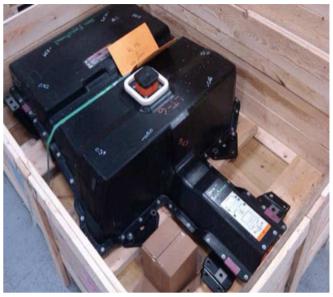
3943206

Take a digital picture of the shipping container depicting the condition of the container as the shipping company picks it up and retain it for the shop records.
