7/13/2023

When applying the brakes at highway speeds the following symptoms may occur:

Transaction No: 2015173/32

46-19-02 - Brake Rotor, Vibration / Pulsation (U.S. Only)

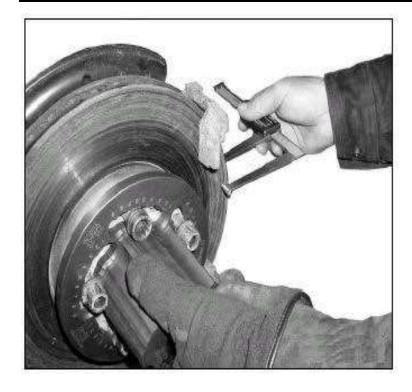
Disc Thickness Measuring

Technician must record the beginning thickness measurements on the back of the repair order.

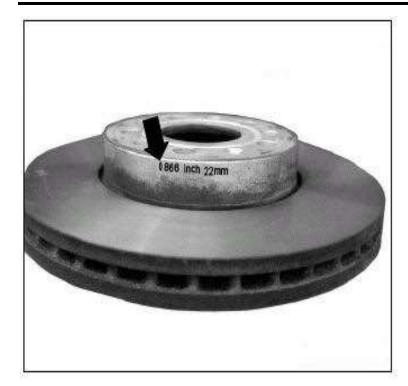
The brake rotor thickness measurement must exceed the minimum specification <u>after</u> the machining process is completed in order to be re-used. If the brake rotor thickness measurement does not meet this requirement after machining, replace the brake rotor.

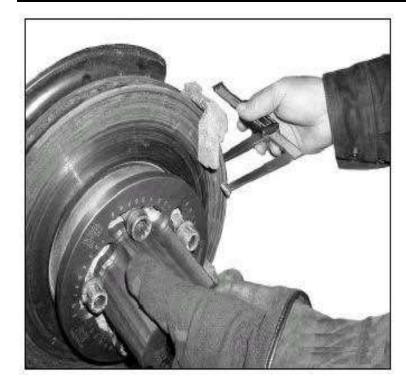
Technician must record the final thickness measurements after machining on the back of the repair order.

Re-measure brake rotor thickness in 4 locations using a digital or mechanical caliper/micrometer. If recorded brake rotor measurement is less than the minimum thickness after machining, the brake rotor MUST be replaced.

Always replace brake rotors in pairs (front axle or rear axle). Do not replace all 4 brake rotors unless it is required.

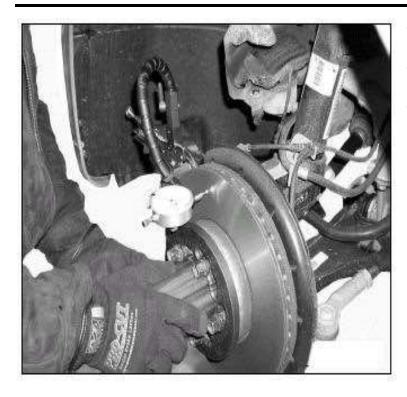
- Measure brake rotor lateral run out using a caliper and dial gauge set.
- Run out must not exceed 0.1mm <u>after</u> machining.
- If brake rotor exceed the 0.1mm specification <u>after</u> machining replace the applicable brake rotors.
