Technical Service Bulletin

01 MIL on, DTC P040100 is stored in the ECM - TDI

01 23 63 2064398/2 July 25, 2023. Supersedes Technical Service Bulletin Group 01 number 23-60 dated July 7, 2023 for reasons listed below.

Model(s)	Year	VIN Range	Vehicle-Specific Equipment
A3 Sportback	2010 - 2013	Not Applicable	TDI

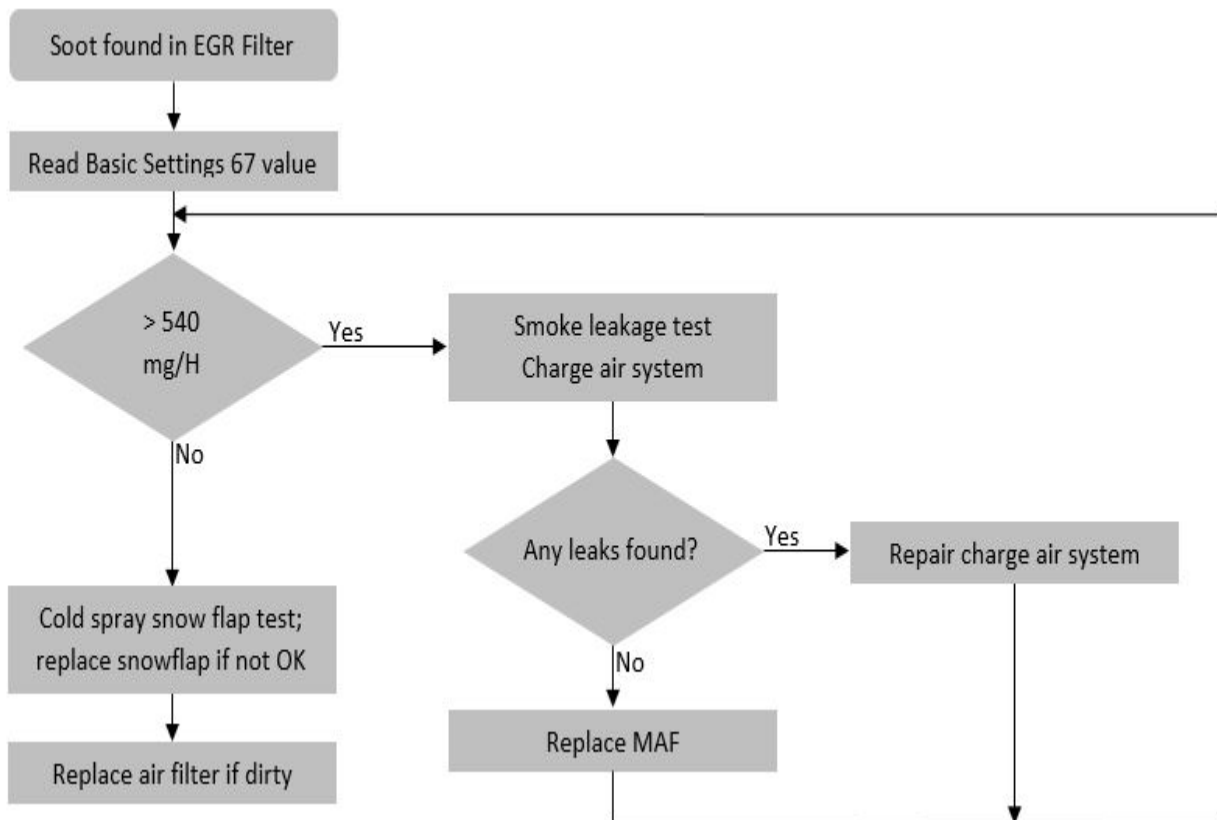
2. If your finger or the cloth comes out with black soot:
 - Replace the DPF & EGR filter together. **The engine must be running correctly with no faults stored to perform the next steps.**
 - **Read out 01 ECM control module OBD Basic Settings block 67 with engine at idle and at operating temperature. Select activate and monitor field 3 when EGR is in OFF position.**
 - **If the MAF actual value is equal to or greater than 540 mg/h, proceed to smoke testing below (there is likely a leak within the intake system).**
 - **If the value is less than 540 mg/h, proceed to the inspection of the snow flap and air filter (TSB attachment). There is no need to smoke test.**
 - Smoke test the charge air system for leaks if MAF value is 540 or great (see procedure below).

Tip: Proper intake airflow is essential for the longevity of the DPF. If a vehicle is found to have a damaged DPF, it is advised to inspect the condition of the intake air filter and verify resting position of the warm air valve (after the vehicle has cooled, see attachment). If the air filter is dirty, advise replacement.

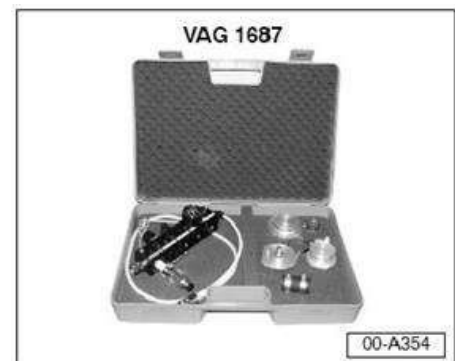
1. The charge air pressure system can be checked using the VAG 1687. Charge air system tester along with the VAG1687/10 adapter as follows:

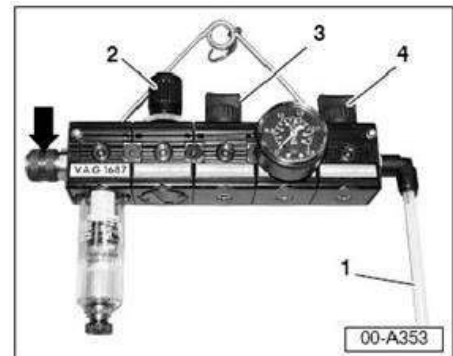
2. Special tool VAG 1687 Charge air system tester, preliminary set-up

- Back off pressure regulator knob -2- of VAG 1687 fully to protect gauge when shop air supply is applied to the assembly.
- Close valve -3- before gauge.
- Close valve -4- after gauge.
- Shop air supply line will later be attached to the inlet of VAG 1687.
- Remove the “female” fitting from the tester (arrow) and install an appropriate “male” air fitting that will connect to your shop air supply line (See Note below).

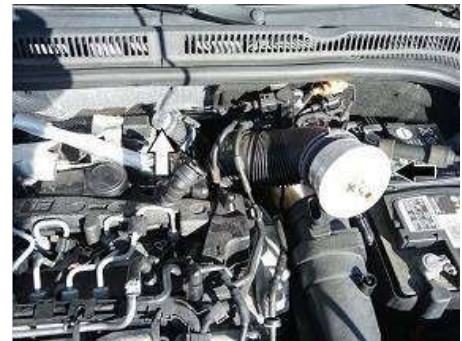
3. Special tool VAG 1687/10 pressure adapter, installing.

- Separate intake hose from the Mass Airflow Sensor assembly (MAF).
- Insert VAG 1687/10 pressure adapter in intake hose -black arrow- using existing clamp (as shown).
- Remove crankcase ventilation valve or tube from intake hose at -white arrow-.
- Plug hose with appropriate metal plug and hose clamps supplied with VAG 1687 special tool kit at -white arrow-.

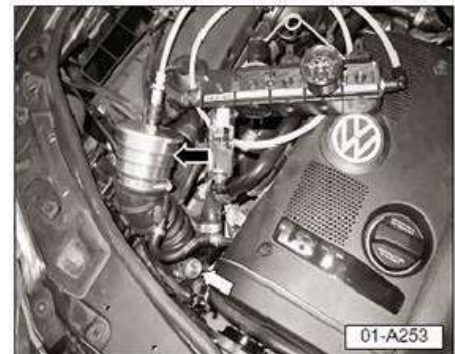
Special tool KLI9210 (EVAP system leak detector)

- Install optional fitting KLI 9210/50 on hose of special tool KLI9210.
- Connect KLI9210 to VAG 1687/1 adapter (KLI 9210 is shown attached to VAG1687/1 at arrow on 1.8L Turbo).

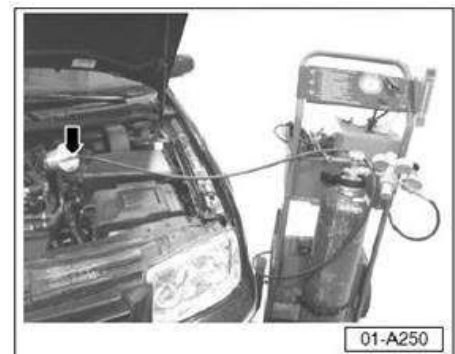
Special tool KLI9210 (EVAP system leak detector)

- Install optional fitting KLI 9210/50 on hose of special tool KLI9210.
- Connect KLI9210 to VAG 1687/1 adapter (KLI 9210 is shown attached to VAG1687/1 at the arrow on 1.8L Turbo).

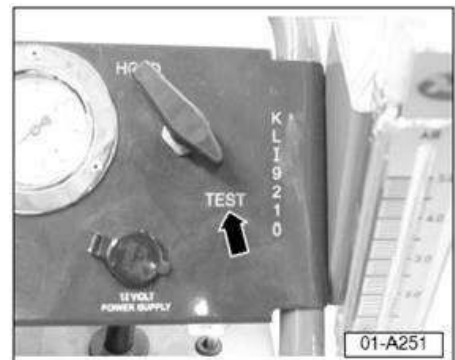
Special tool KLI9210 (EVAP system leak detector), preliminary set-up:

- Setup KLI 9210 as described in the user manual regarding self-test and output pressure.
- Connect the smoke generator leads to the vehicle battery.
- Turn the valve to test (black arrow).
- Press the smoke generator button to fill the system with smoke (see instructions printed on the tester).
- Check for escaping smoke for two minutes.

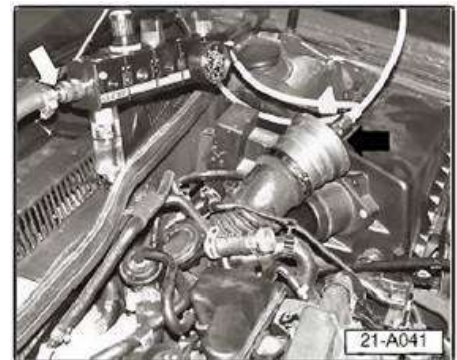
Special tool VAG 1687 connecting to pressure adapter 1687/10

- VAG 1687 is shown connected to VAG 1687/10 (black arrow).
- Shop air supply connected to VAG 1687 at (white arrow).
- Perform pressure test.

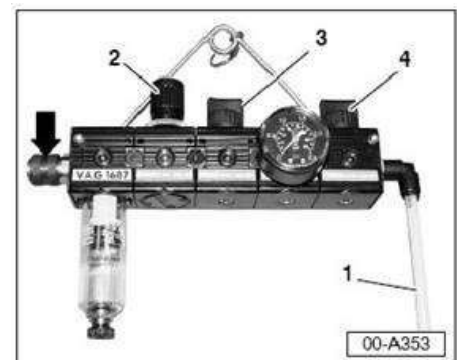
Performing the Pressure Test:

- With outlet the hose -1- of VAG 1687 connected to the air pressure adapter.
- Attach the shop air supply line to the previously installed male fitting.

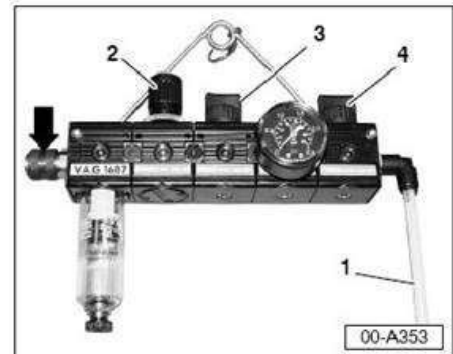
- Slowly open outlet valve -4- (after gauge) to test hose connections.
- Observe the pressure gauge for a drop in pressure.
