# TECHNICAL SERVICE BULLETIN

Technical Service Bulletin: 64-1656

# TECHNICAL SERVICE BULLETIN 64-1656 REMEDY INSTRUCTIONS

Make(s): CHEROKEE & CASCADE Model(s): MANY, SEE BELOW Model Year(s): 2023	Repair Code: SB-431-22-00-004376 Allotted Time: .30 HRS. Inspection Code: SB-431-05-00-004375 Allotted Time: .10 HRS.
	Concern: THE FREEZE SENSON WIRE MAY BE INCORRECTLY WIRED INTO THE GROUND SIDE OF THE AIR CONDITIONER.	Photo(s) Required: YES, POST REMEDY Prior Authorization Required: YES Part(s) Number: F100431666 Part(s) Return: NO

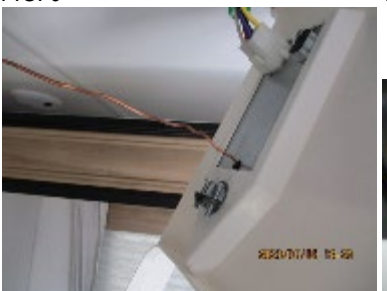
FIG. 7

Manufacturing may have connected the freeze sensor wire to the ground of the 110v side of the air conditioner. This may cause the thermostat to become non-operable.

- STEP 1: DISCONNECT EXISTING FREEZE SENSOR WIRE FROM THE 110 VOLT GROUND CONNECTION;
- STEP 2: REMOVE COVER FOR THERMOSTAT. REMOVE THERMOSTAT FROM HOUSING;
- STEP 3: INSTALL NEW THERMOSTAT (FIG. 4 & 5) AND REINSTALL ACCESS COVER;
- STEP 4: INSERT COPPER FREEZE SENSOR WIRE COMING OUT OF THERMOSTAT INTO THE AC COILS (FIG. 6 & 7);
- STEP 5: REASSEMBLE NON-DUCTED ASSEMBLY AND COVER TO COMPLETE REPAIR;
- STEP 6: TEST FUNCTIONALITY OF THE AIR CONDITIONER;
- STEP 7: CLAIM REPAIR CODE.
