MAS003627 RU 23-23

Rapid Update 632 Grecale – Top Strut Mount Check

DATE: JUNE 8 2023

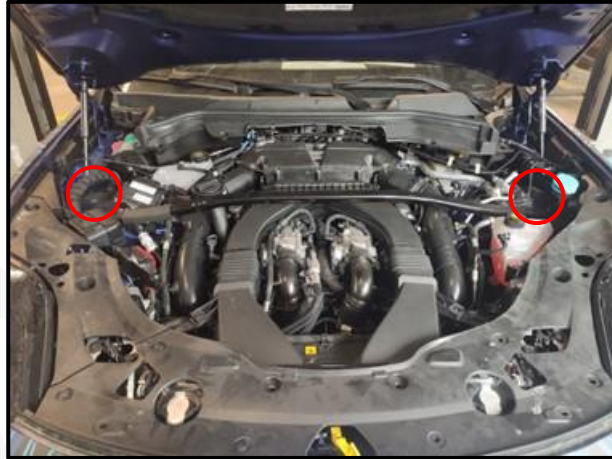
4. Using leak detection liquid (e.g., Snoop Leak Detector) or an equivalent, check for air leaks in the areas circled in **GREEN** (both the Driver and Passenger side engine compartment and in the wheel well compartment areas) Make sure to spray the entire circumference of the areas shown.

- **OK** ▶ No leak has occurred; the procedure is finished. No further action needed.
- **NOT OK** ▶ Air leak found (formation of bubbles). Replace the complete shock absorber assembly that is leaking following the procedure in the workshop manual.
 - a. **6.11.001 RH FRONT SHOCK ABSORBER** **Removal-Refitting or Replacement**
 - b. **6.11.002 LH FRONT SHOCK ABSORBER** **Removal-Refitting or Replacement**
