| HYUNDAI Technical Service Bulletin | GROUP AUTOMATIC TRANSMISSION | NUMBER 23-AT-008H |
| SUBJECT: AUTOMATIC TRANSAXLE (8-SPEED FWD) POSITION SENSOR DTC P070500, P070512, P070514, P07051C, P070600, P070661 & P070696 DIAGNOSIS | | |

This TSB supersedes TSB 21-AT-007H to revise Parts Information, add HMMA built Santa Fe Hybrid (TMA HEV) and add information for Santa Fe (TMA), Step 8.

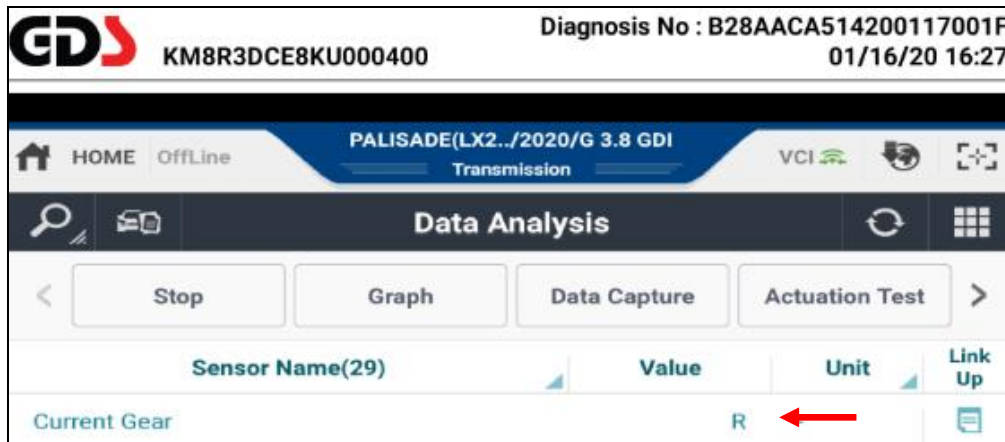
1. Start the engine.
2. Attach a GDS and check for DTC in the “Automatic Transaxle” menu. **Record the DTC and description.** Delete the DTC.
3. Select **Data Analysis, A/T** menu and **Current Gear**. Depress the brake pedal and move the shift lever through all gears (P, R, N and D) and monitor the **Current Gear**. Confirm the indicator on the cluster shows all gears. Turn the ignition **OFF**.
