GROUP	NUMBER
CAMPAIGN	23-01-052H-1
DATE	MODEL(S)
JULY, 2023	TUCSON HYBRID (NX4 HEV) & SANTA FE HYBRID (TM HEV)

Technical Service Bulletin

COOLING SYSTEM CIRCUIT DEBRIS DISCHARGE AND COOLANT SUBJECT: CHANGE (SERVICE CAMPAIGN T9L)

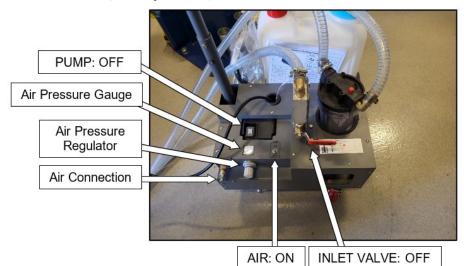
- 1. Air Draining (Coolant discharge)
 - a. When discharging the remaining coolant using air, turn off the coolant pump and close the inlet valve. (If the inlet valve is opened, the air may flow back and the remaining coolant may not be recovered.)
 - b. Equipment setting condition:
 - i. Air 'ON', Pump 'OFF', Inlet valve 'OFF'

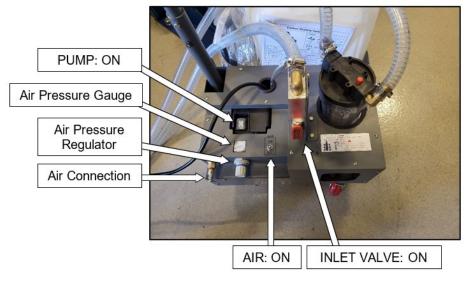
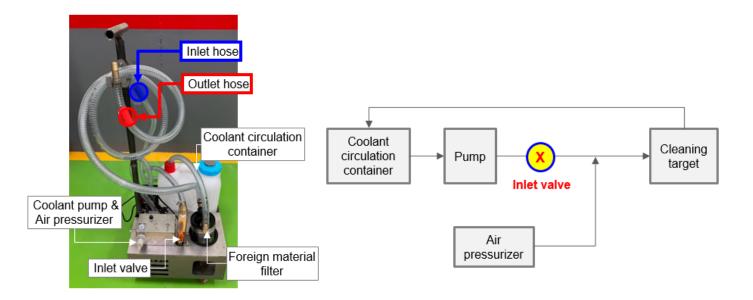
- c. The air pressure can be adjusted up to 3 bar to achieve desired draining performance.
- 2. Coolant Cleaning (Flushing and filtering of the vehicle's coolant circuit)
 - a. Equipment setting condition:
 - i. Pressure 2 bar, Air 'ON', Pump 'ON', Inlet valve 'ON'
