**SERVICE BULLETIN**

**APPLICABILITY:** 2019-23MY Ascent

**NUMBER:** 09-107-23

**SUBJECT:** DTC P2404 / Reprogramming Files

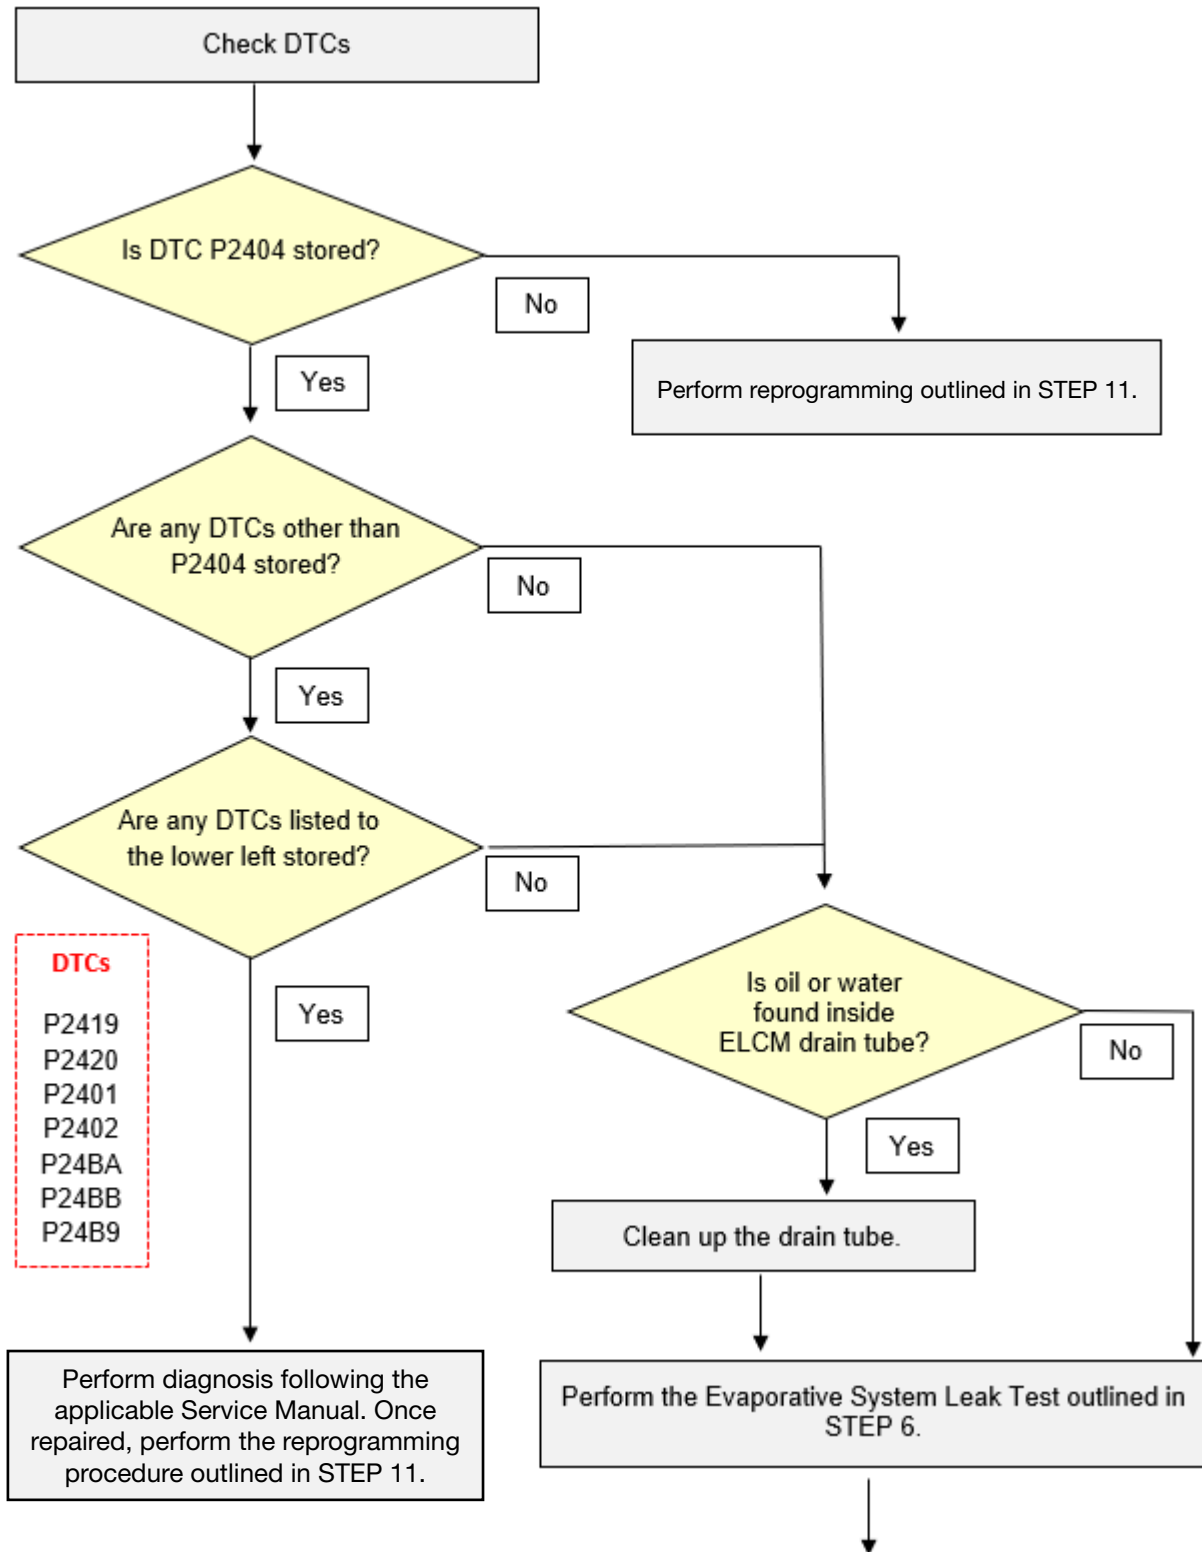
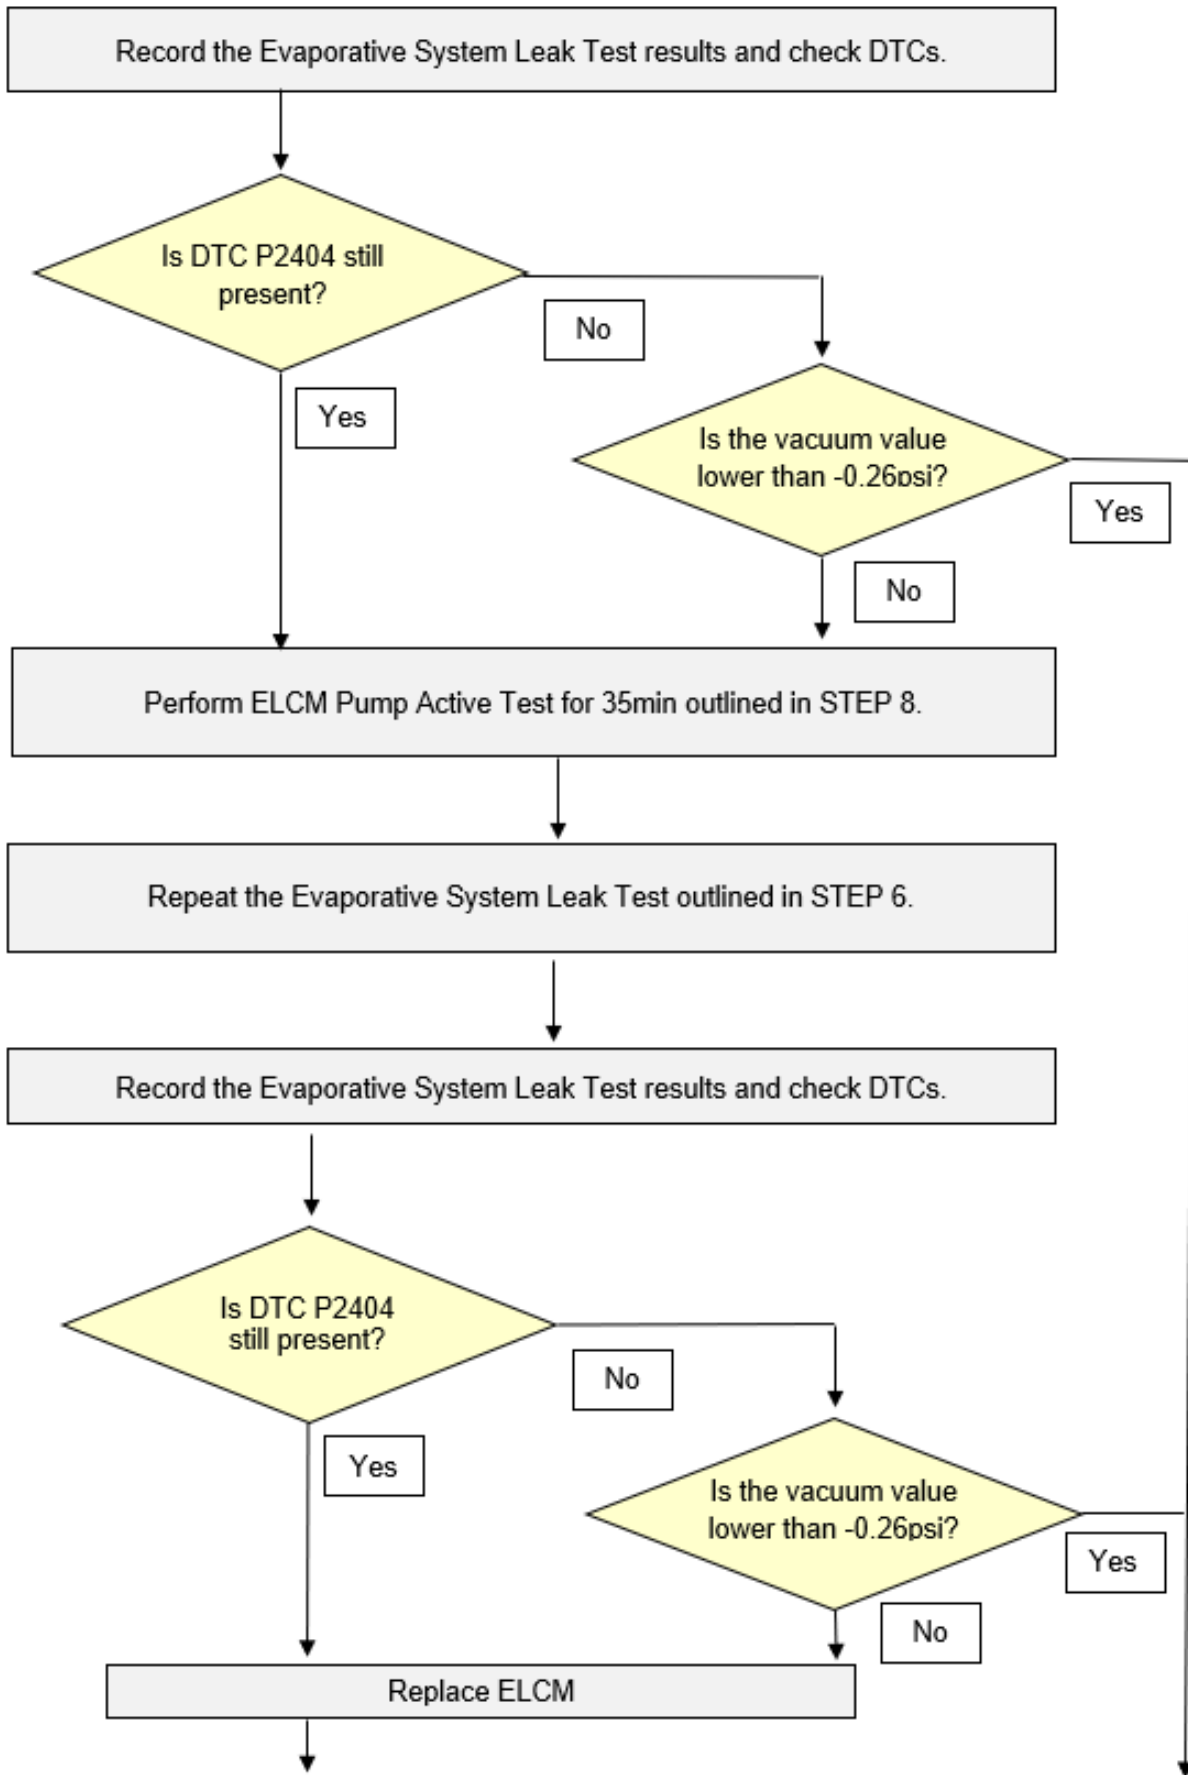
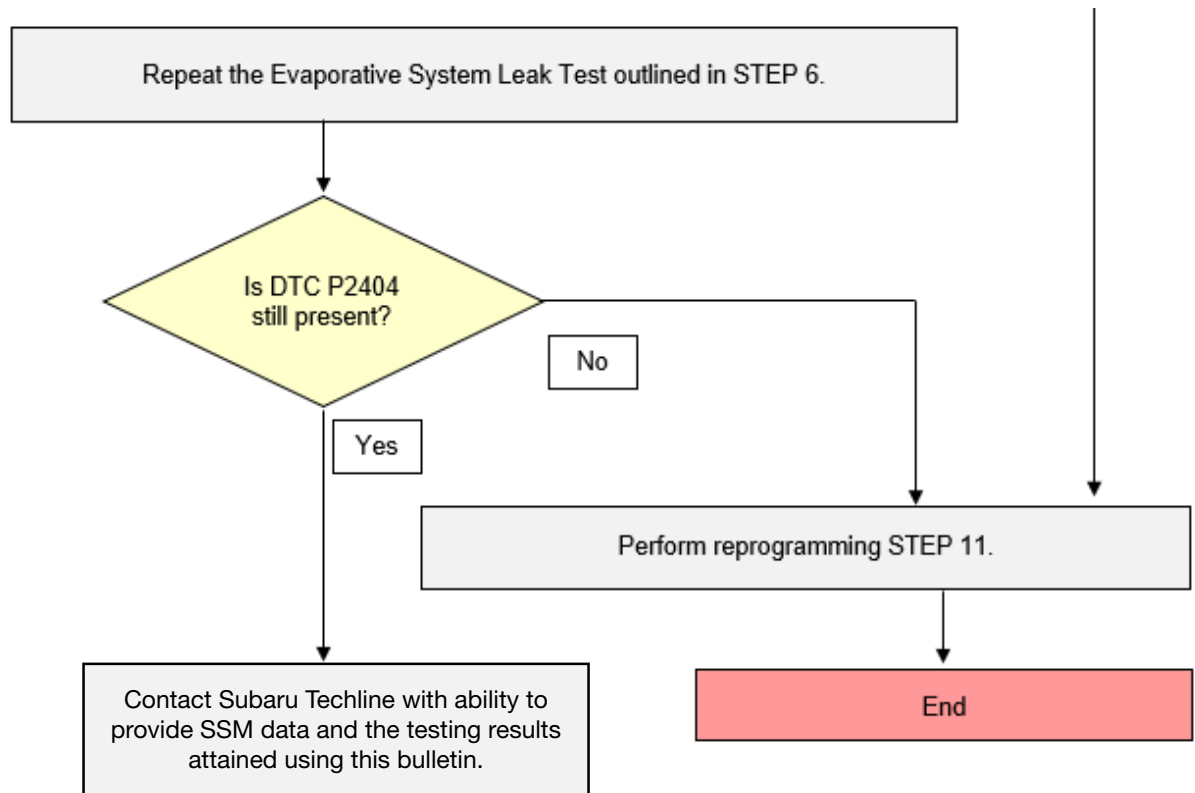
**SERVICE PROCEDURE FLOWCHART:**

This bulletin announces diagnostic procedures and availability of new Engine Control Module (ECM) reprogramming files to address DTC P2404 (Evap System Leak Detection Pump Sense Circuit Range/Performance) detection. In rare cases, the internal pump for the Evaporative Leak Check Module (ELCM) system can seize temporarily. The new files contain enhanced logic to prevent the ELCM pump from seizing. If P2404 is found in the fault memory, follow the diagnostic procedures outlined below.

**STEP 1:** Using Subaru Select Monitor (SSM), check for diagnostic trouble codes. Confirm P2404 is stored and proceed to the next step.

**STEP 7:** Was the vacuum value result observed in STEP 6 found to be lower than -0.26 PSI?

- YES** – Proceed to STEP 11.
- NO** – Repeat the Evaporative System Leak Test (outlined in STEP 6) then proceed to STEP 9.

**STEP 10:** Replace the Evaporate Leak Check Module and repeat the Evaporative System Leak Test outlined in STEP 6. Check the DTCs and the vacuum value results.

**STEP 11:** Reprogram the ECM following the normal FlashWrite procedure. See **APPENDIX A** for addition information regarding power supply recommendations.
