## Technical Service Bulletin

GROUP	NUMBER
<b>BODY ELECTRICAL</b>	<b>23-BE-009H</b>
DATE	MODEL(S)
<b>JULY 2023</b>	<b>VENUE (QX)</b>

**SUBJECT:** HORN ASSEMBLY WARRANTY EXTENSION (TXXU) AND REPLACEMENT

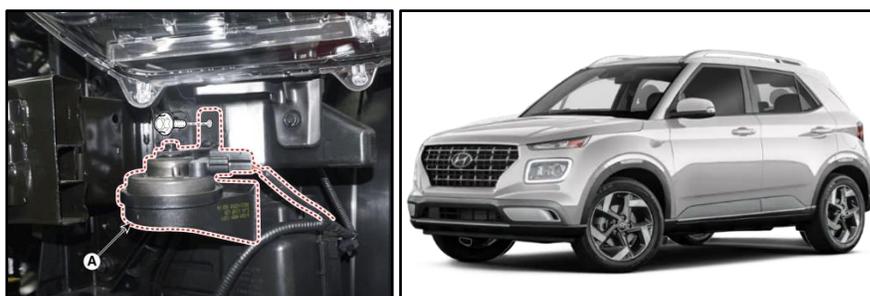
**Description:** Certain 2020-22MY Venue (QX) vehicles may experience an inoperable horn that may be caused by foreign substances causing internal parts to oxidize.

This bulletin provides information on how to fix the inoperative horn.
