Complaint - Cylinder Head Cover Near the Injector Holes Leaking: Subsequent Work on Cylinder Head (180/18)

Vehicle Type: **Macan S (95B) / Macan GTS (95B) / Macan Turbo (95B)**

Concerns: **Cylinder head cover**

Cause: **Complaint about injector hole leaks**

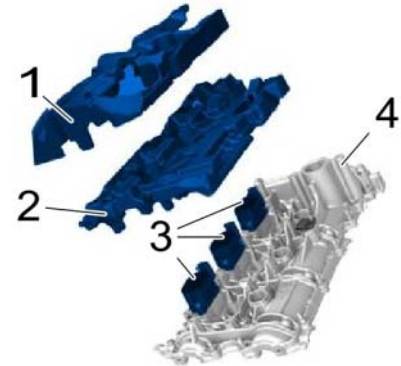
Cylinder head cover component overview

- 1 – Insulation on top of cylinder head cover
- 2 – Insulation on bottom of cylinder head cover
- 3 – Hydraulic valve for valve lift switchover
- 4 – Cylinder head cover
