Subject: DOOR OUTER HANDLE TOUCH SENSOR DOES NOT WORK (LOCK AND/OR UNLOCK)	Bulletin No.: 09-029/23
	Last Issued : 07/10/2023

APPLICABLE MODEL(S)/VINS

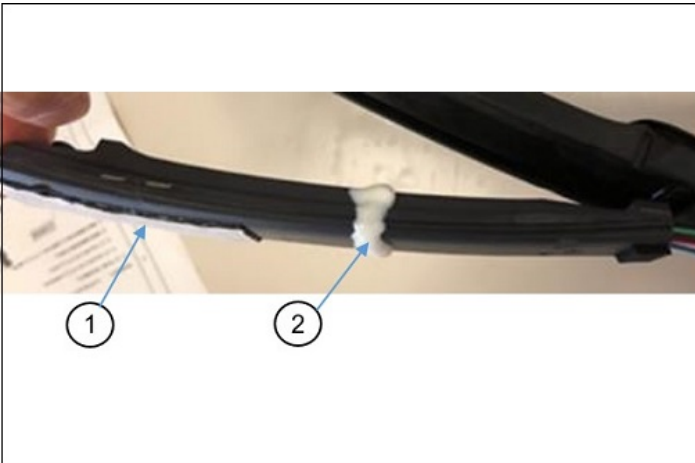
View A

- (1) Butyl tape
- (2) Adhesive: Apply the adhesive around the touch sensor

4. Waterproof the outer handle and the touch sensor by applying adhesive to the touch sensor.
