Service Alert

Mazda North American Operations
Irvine, CA 92618-2922

Subject: CONNECTED VEHICLE SYMPTOM TROUBLESHOOTING	Service Alert No.: SA-009/23
	Last Issued : 07/05/2023

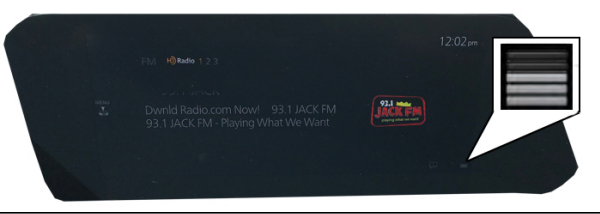
Infotainment Center Display	<p>TCU Active</p>	<p>Reception Icon Shows normal strength</p>

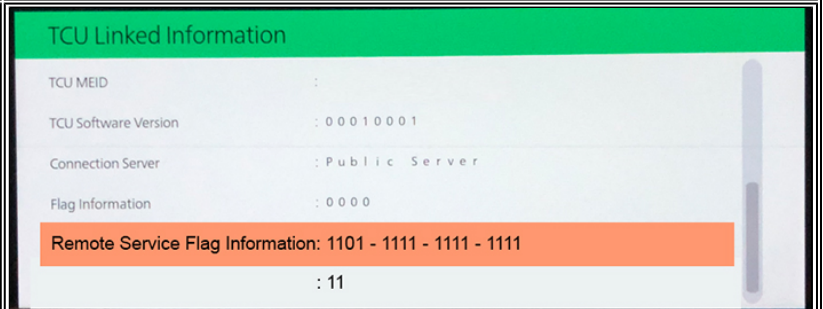
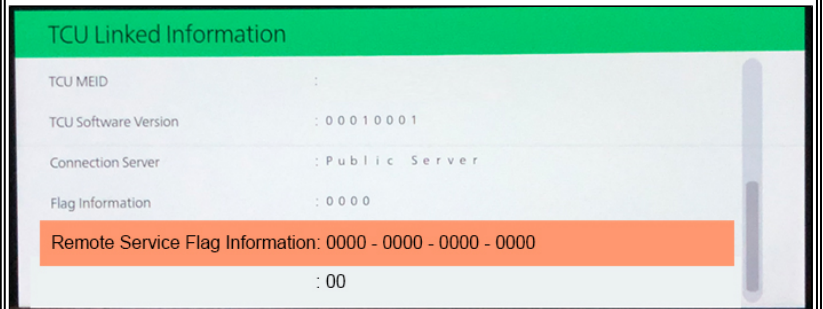
Is the Remote Service Flag Information 1101... or 0000...?

- **1101...** - Disconnect 12V battery for 1 hour, then retry connected vehicle enrollment.
- **0000...** - Contact Hotline for technical support.
