# TECHNICAL SERVICE BULLETIN

Classification: EL22-011B	Reference: NTB22-051B	Date: July 11, 2023
------------------------------	--------------------------	------------------------

## HORN INOPERATIVE

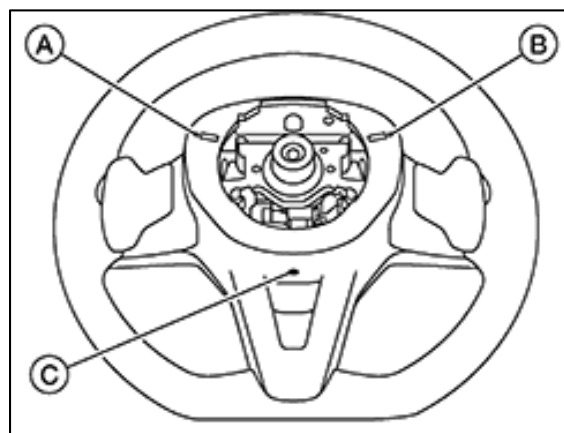
Figure 2

3. Locate the two (2) access holes on the back of the steering wheel and the one (1) access hole on the bottom of the steering wheel (Figure 2).
  - A. Right side access hole
  - B. Left side access hole
  - C. Bottom access hole

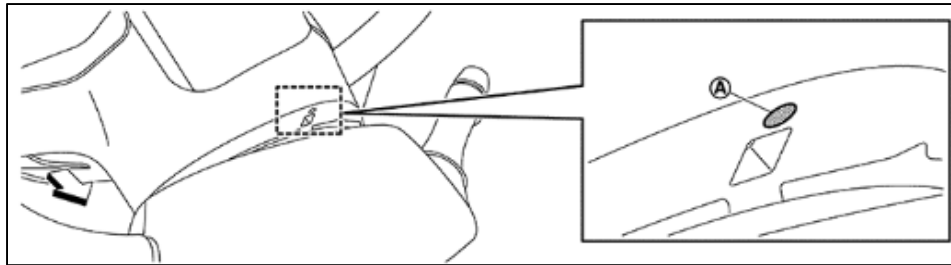
Figure 3

4. Turn the steering wheel until the access hole (A) is visible from the top of the steering column (Figure 3).

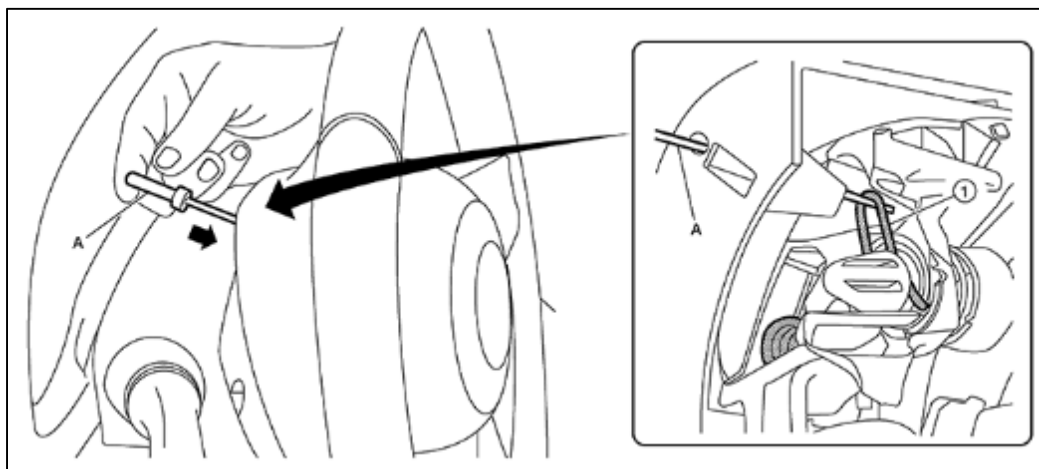
Figure 4

5. Insert the Airbag Release Tool (A), into the access hole and under the spring (1), as shown in Figure 4.

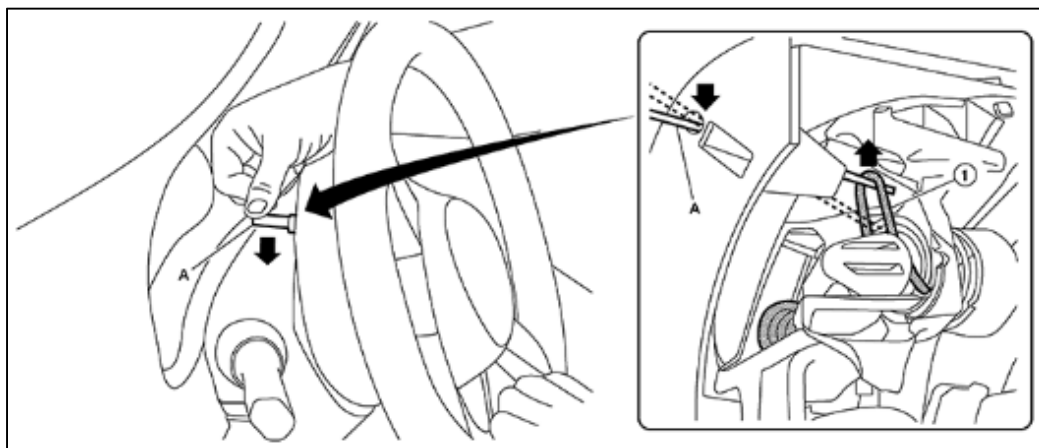
Figure 5

6. Lift the spring (1) using the Airbag Release Tool (A), to disengage the spring, as shown in Figure 5.

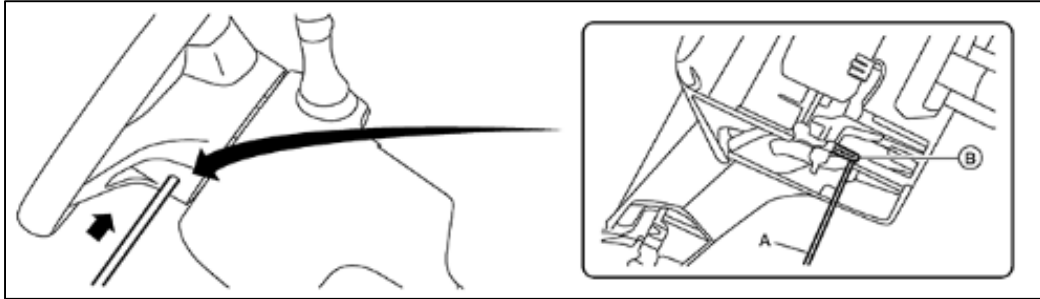
Figure 6

7. Turn the steering wheel in the opposite direction, and then repeat steps 4 - 6 to release spring B (Figure 2 on page 3).
8. Using the Airbag Release Tool (A), gently push the bottom pawl (B) and gently tilt the bottom of the driver airbag module outward so that the pawl will not re-engage, and then pull out the driver airbag module.
