GLOBAL SAFETY FIELD INVESTIGATIONS  
DCS6639  
URGENT - DISTRIBUTE IMMEDIATELY

Subject: N232411300 - Service Update  
Brake Fluid Leak

Models: 2023 Chevrolet Silverado 4500 HD/5500 HD/6500 HD

## N232411300 Brake Fluid Leak

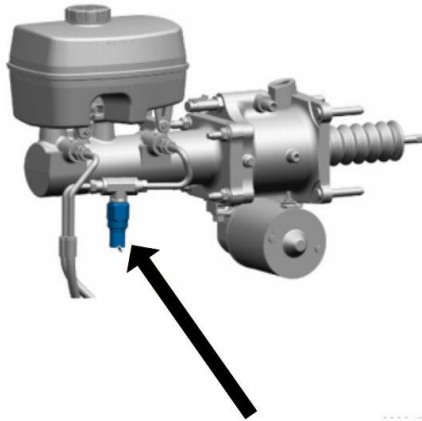
6396346

6. Locate Brake Pressure Switch (shown above).

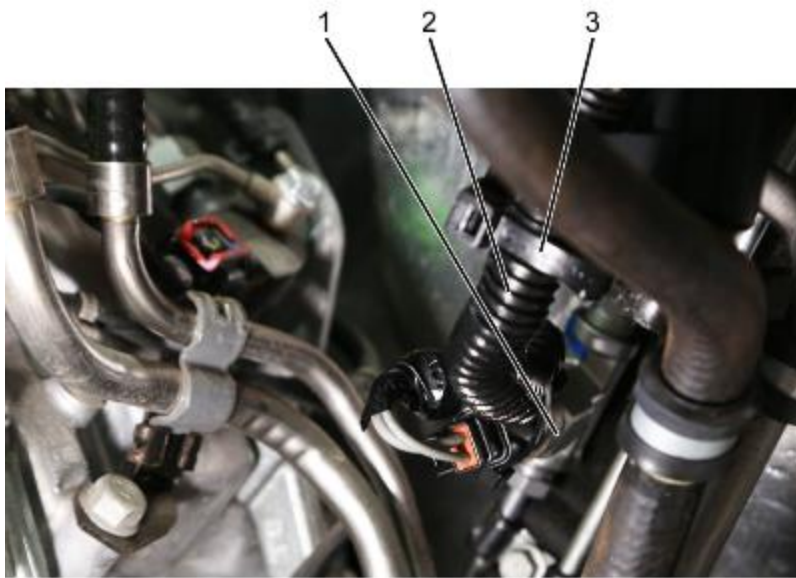
6361848

8. Disconnect the Harness Connector (2) from the Brake Pressure Switch (1).

**Note:** Some vehicles may have dielectric grease in the switch/connector, this should not be confused with brake fluid.
