| Title: | MCC HVAC Upgrades | | | |
| Number: | SB_588.4 | Release Date: | 6/20/2022 | |

## **Subject:**

Addressing fault codes and upgrades to the Midwest Climate Control (MCC) HVAC system.

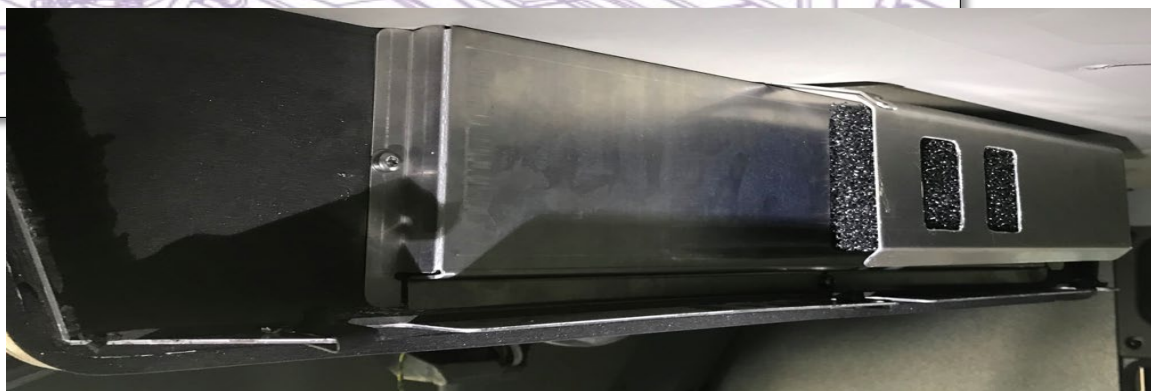
This will eliminate unnecessary messages and only display the faults that are currently active which will save time on troubleshooting and part replacements. The upgrade also allows the temperature to be controlled in defrost mode. To ensure that the AC system operates correctly and doesn't spray condensation through the vents, an internal baffle needs to be added to the diffuser as part of the air balancing package that also increased fan speed.
