Technical Info

FROM: Maserati TSO

Grecale - New Granturismo: air suspension system check

DATE: JULY 11, 2023

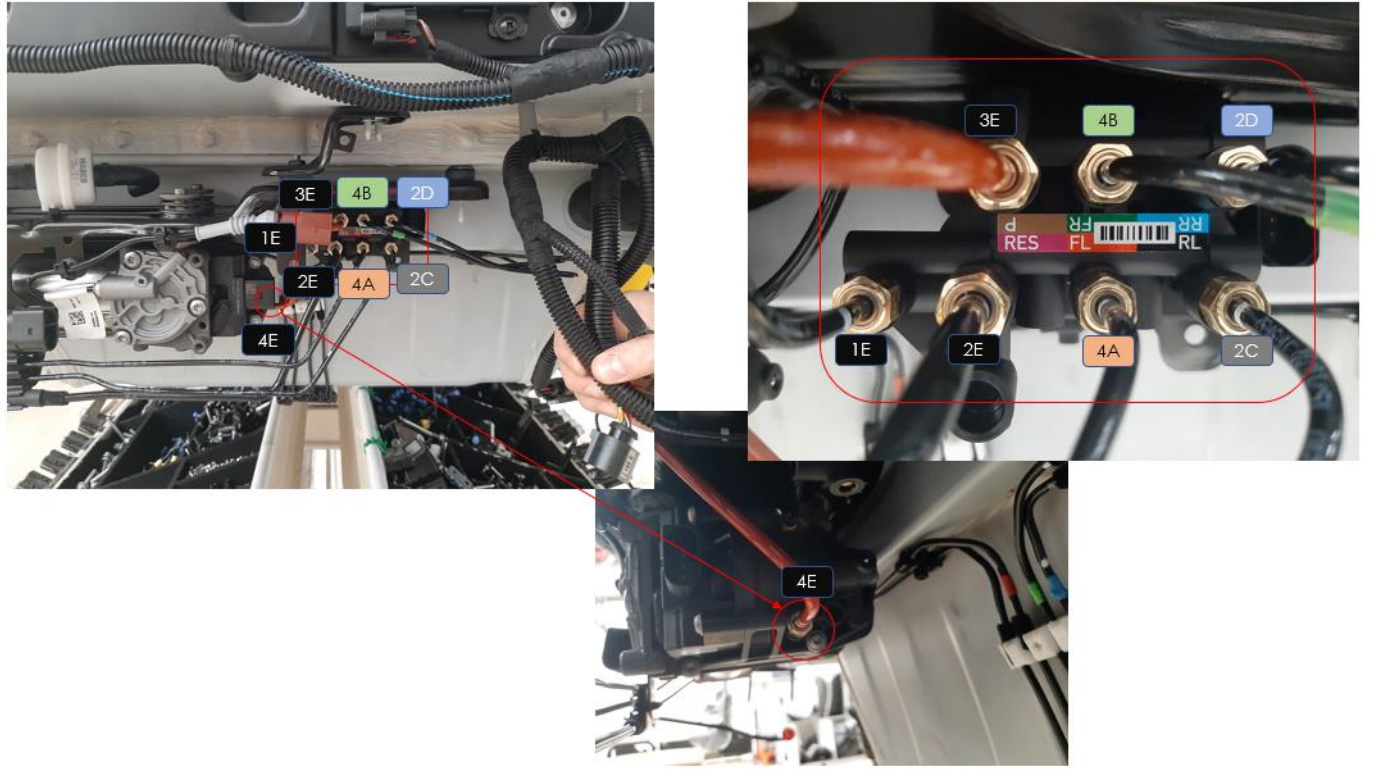
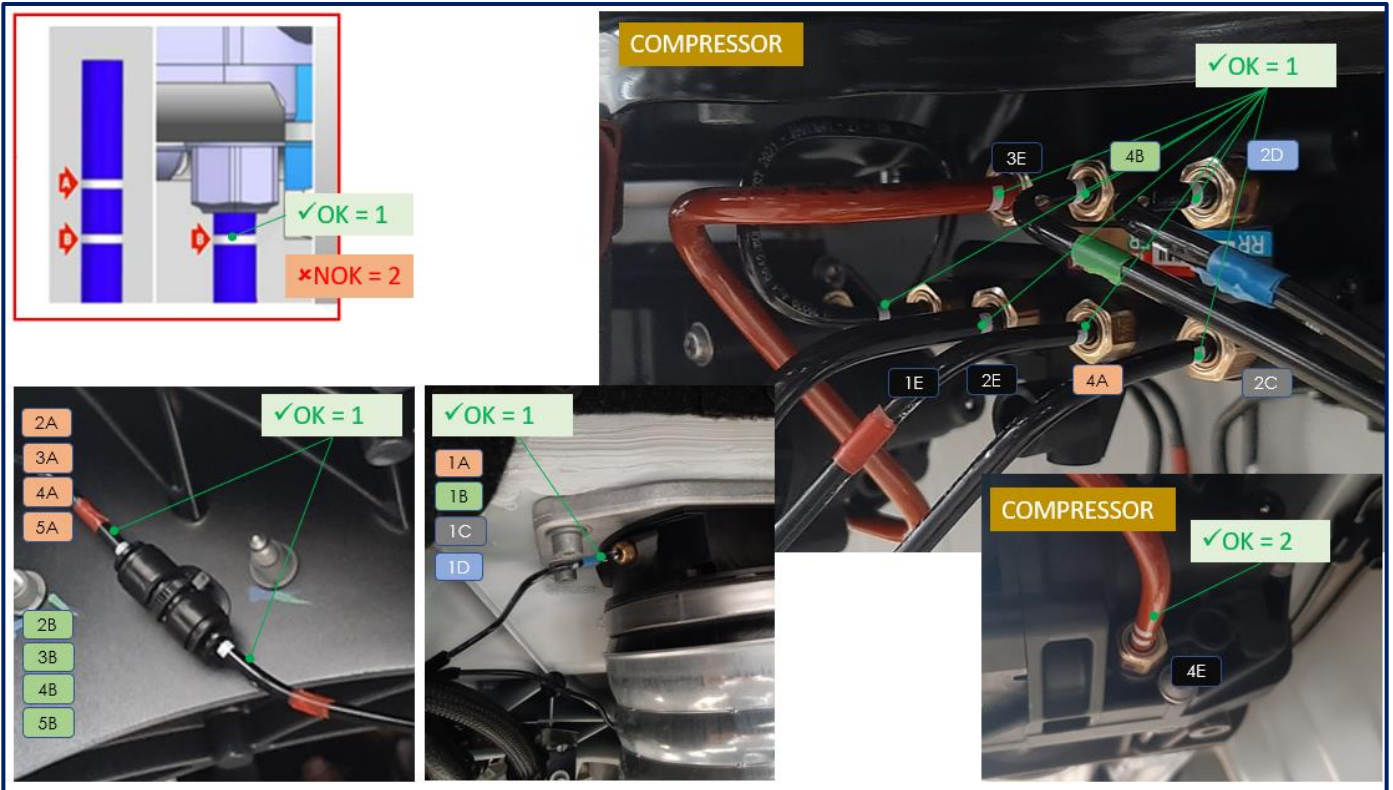
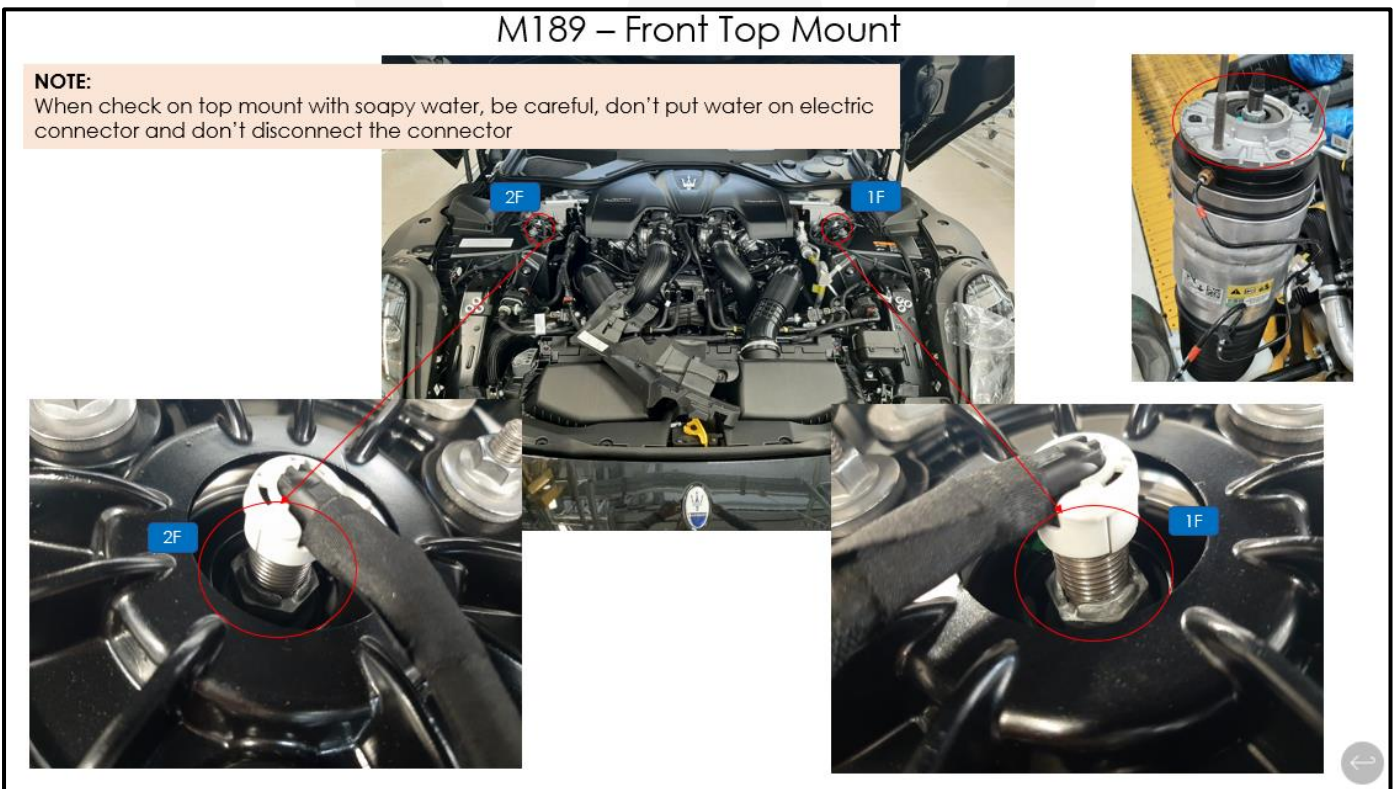
M189 - Compressor - Pipe connections

Use soapy water to detect potential air leak through the system.

Fill in the inspection point checklist.
