Tesla, Inc. Service Bulletin		Replace Occupant Classification System (OCS) of Front Passenger Seat while Servicing Subcomponents			
SB-23-20-002 June 16, 2023		R5					
Classification		Section/Group		Mobile Service		Configuration	
Repair Bulletin		20 - Safety and Restraint		Can Perform (where permitted)		All	
Model Year		Model		Country/Region		Build Location	
2017 - 2023		Model 3, Model Y		North America, Asia Pacific		Fremont, Giga Austin	
The model(s) and model year(s) listed are a general approximation of the affected VIN list. Refer to the VIN/Bulletin Tracker or Customer/Vehicle profile to determine applicability of this bulletin for a particular vehicle.

Condition

Certain Model 3 and Model Y vehicles may need a different Occupant Classification System (OCS) installed in the front passenger seat before servicing its subcomponents.

Correction

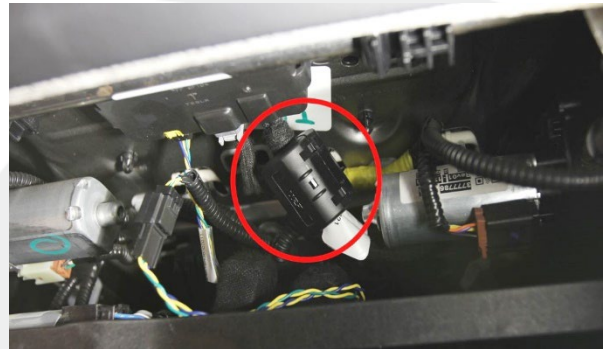
Figure 6

- If a ferrite is installed on the old self-capacitance electrical harness (Figure 5):

- Remove the felt tape that attaches the ferrite to the self-capacitance electrical harness, and then remove the ferrite from the harness and set aside for reinstallation.
- Once the replacement passenger seat harness is fully installed, position the new self-capacitance electrical harness into one half of the ferrite, and then clamp the other half of the ferrite closed (Figure 6).
- Completely wrap the ferrite and self-capacitance electrical harness together with felt tape to prevent NVH issues.
