Subject: N232398360 - Customer Satisfaction Program  
Loss of OnStar Audio

Models: 2016 Buick Envision

# Customer Satisfaction Program

## N232398360 Loss of OnStar Audio

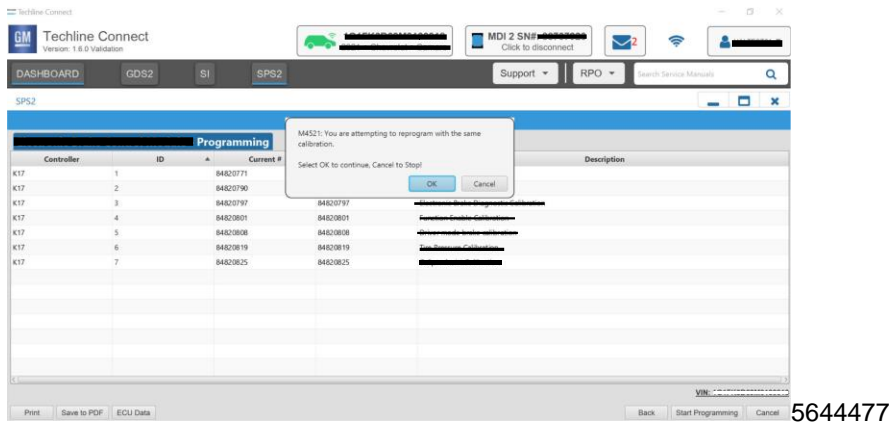
**Important:** Techline Connect screens shown above.

**Important:** If the same calibration/software warning is noted on the TLC Summary screen, select OK and follow screen instructions. After a successful programming event, the WCC is located in the Service Programming System dialogue box of the SPS Summary screen. No further action is required. Refer to the Warranty section of the bulletin.
