Release Date	08/03/2023	Technical Service Bulletin		
<b>42M6 UPDATE</b>

<b>Rear Suspension Adjustment Bolts – (NVLW)</b>

This Update has been proactively released to prevent the following condition(s) from occurring in the vehicle:	
Criteria	Technical Background
01	Rear suspension bolts may not have been properly torqued. Rear suspension bolts that are not correctly tightened may cause the alignment angles of the rear suspension to change over time. If this occurs, this can lead to pre-mature tire wear.

Criteria	Remedy
01	Check the rear axle alignment and torque of the rear suspension adjustment bolts. If the any of the bolts are not at the correct torque, the rear axle alignment will be corrected as needed and the adjustment bolts torqued to the proper specification. The tires will be checked for premature and uneven wear. If found, the tires will be replaced as necessary.

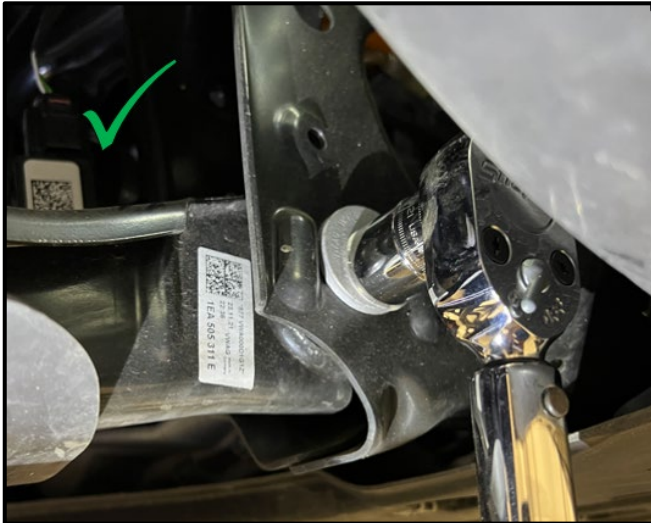
- If all of the suspension adjustment nuts are found to be at the correct torque specification:
  - No further work is required.

If the suspension adjustment bolts are found to be at the correct torque and the alignment is out of spec, correction of the alignment is **NOT** covered by this update.

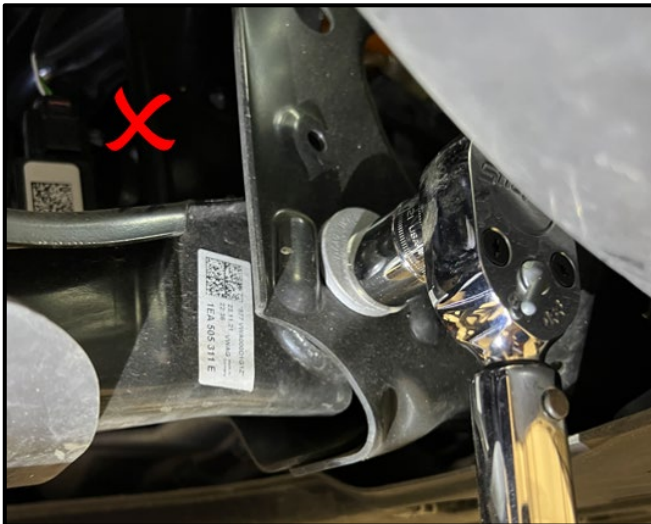
- If any of the suspension adjustment nuts are not at the proper torque:
  - Check if the rear axle alignment is out of specification per the wheel alignment program.
- If the alignment is within spec:
  - **Proceed to section B.**
- If the alignment is **NOT** within spec:
  - **Proceed to section C.**
