Technical Service Bulletin

01 MIL on, DTC P040100 is stored in the ECM - TDI

01 23 68 2064398/3 August 11, 2023. Supersedes Technical Service Bulletin Group 01 number 23-63 dated July 25, 2023 for reasons listed below.

Model(s)	Year	VIN Range	Vehicle-Specific Equipment
A3 TDI	2010 – 2013	All	Not Applicable

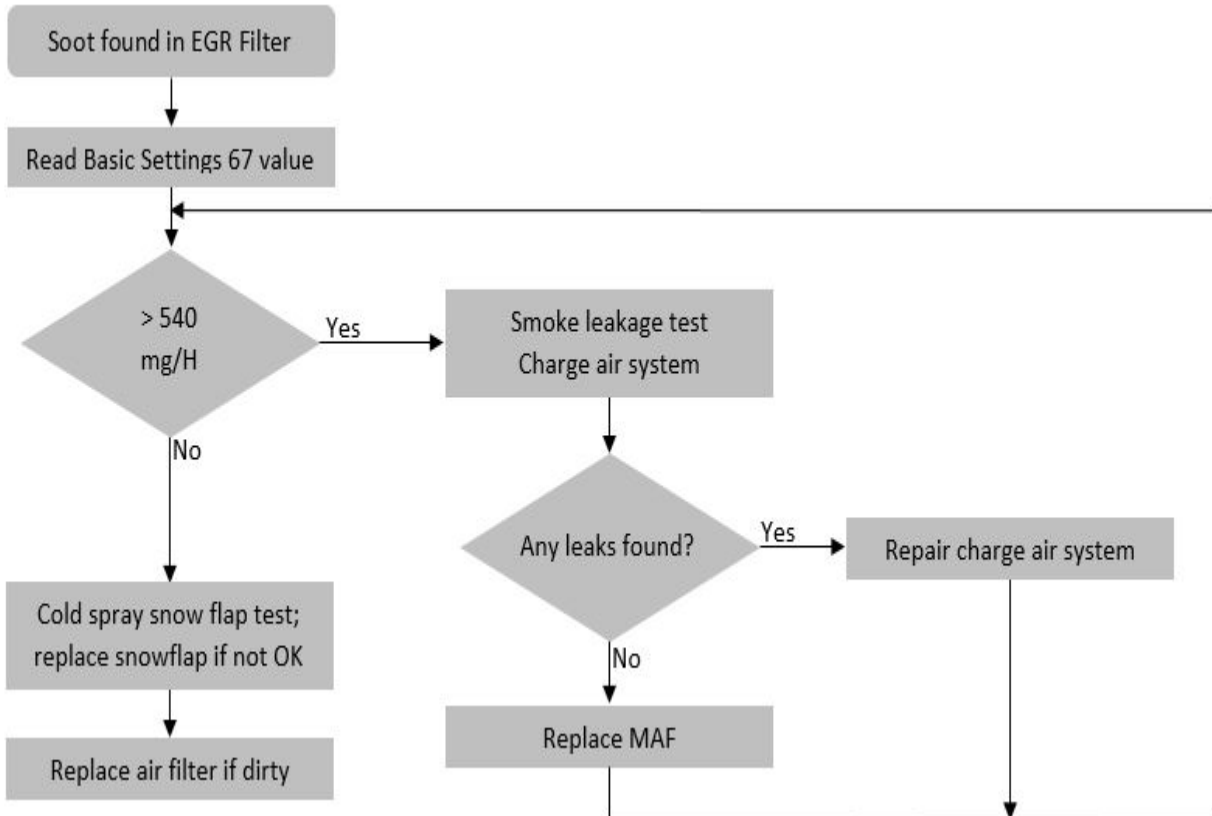
Tip: Proper intake airflow is essential for the longevity of the DPF. If a vehicle is found to have a damaged DPF, it is advised to inspect the condition of the intake air filter and verify resting position of the warm air valve (after the vehicle has cooled, see attachment). If the air filter is dirty, advise replacement.
