SIB 52 09 20

HEAD RESTRAINT AND/OR BACKREST OF 3RD ROW SEATS CANNOT BE FOLDED DOWN

E-Series	Model Description
G07	X7 Sports Activity Vehicle

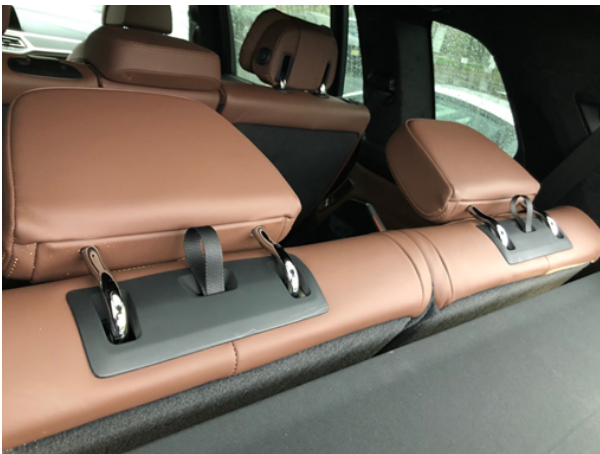
1. Head restraint cannot be folded down:

YES = Head restraint mechanism is faulty. Determine root cause of Bowden cable not moving (see steps below). If the cable is moving fully but the headrest is not folding, then replace the folding module of the head restraint (#2 in picture).

If the Bowden cable is mounted properly and cable correctly routed and the electric motor moving the common housing pulls all 3 Bowden cables equally but the headrest Bowden cable does not travel far enough, replace the Bowden cable for the headrest (shown in yellow in picture).

See REP 52 30 118 Remove and install/replace folding module of left or right head restraint

See REP 52 30 253 Replace Bowden cable for left or right head restraint (Bowden cable unlocking device for head restraint).
