Service Alert

Subject: CONNECTED VEHICLE SYMPTOM TROUBLESHOOTING	Service Alert No.: SA-009/23
	Last Issued : 08/15/2023

2019-2024 Mazda3
2020-2024 CX-30
2021-2024 CX-5
2021-2023 CX-9
2022-2023 MX-30
2023-2024 CX-50
2024 CX-90

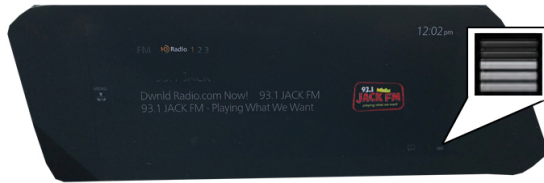
MAZDA CONNECT Indication

Indication	Explanation
Mazda3, CX-30, CX-50, MX-30

Radio waves are not being received. Move to a location with good reception.

Weak reception.

Good Reception

Strong reception.

Currently conducting an operation check of the communication unit. If this condition continues, consult an Authorized Mazda Dealer.

Currently conducting an operation check of the onboard communication unit. NOTE: Communication is not possible during this display.
CX-5, CX-50, CX-9, MX-30 Mazda3, CX-30 built July 1, 2021 and later

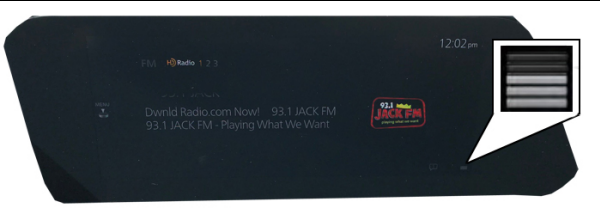
<p>Infotainment Center Display</p>	<p>TCU Active</p>	<p style="text-align: center;">Reception Icon Shows normal strength</p>

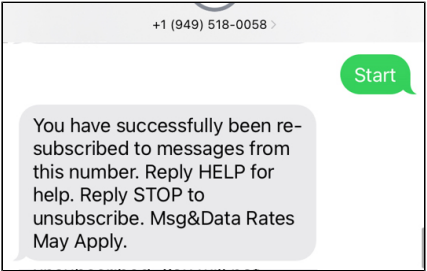
Connected Vehicle Troubleshooting		
Symptom	Cause	Action
<p>The customer is not able to create a MyMazda account. The customer receives the following error:</p> <p>MyMazda App - Internal Usher SDK error.</p>

<p>MyMazda Website - ERROR! Unable to send one-time password.</p>	<p>Customer inadvertently texted "Stop" to 1-949 518-0058 (Twilio SMS for Mazda)</p>	<ol style="list-style-type: none"> Text "Start" to 1-949 518-0058 (Twilio SMS for Mazda) Retry to create a MyMazda account. <p>NOTE: USA and Canada only</p>

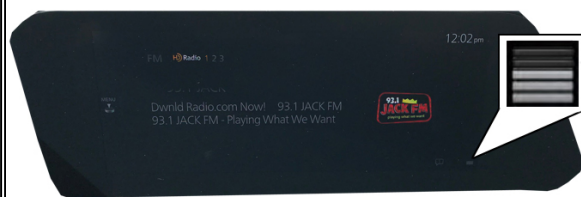
- Reception strength icon shows normal strength. TCU is now active. Proceed to **Enrollment**.

- Reception strength icon shows "X". TCU activation is still processing. Repeat steps 16-18.

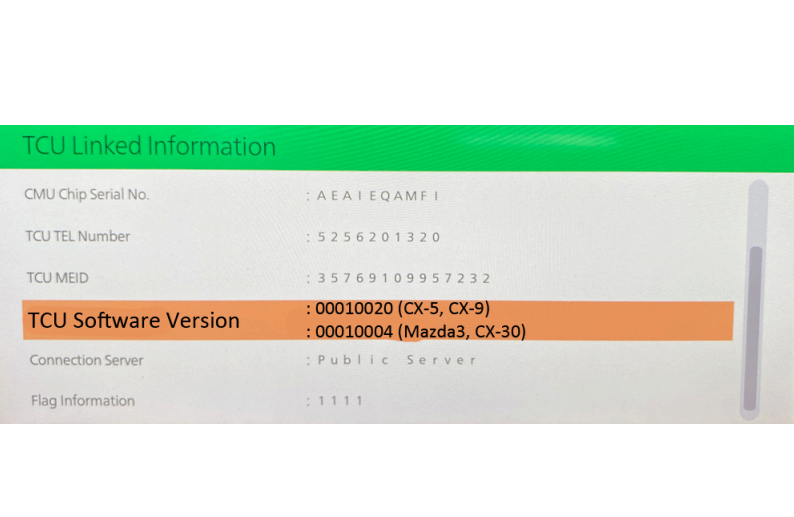
<p>4. Scroll down to TCU Software Version and confirm the software version is at:</p> <ul style="list-style-type: none"> • Mazda3 - 10006 or later • CX-30 - 10006 or later • CX-5 - 10023 or later • CX-9 - 10023 or later • MX-30: 10019 or later • CX-50: 10003 or later <p>Is the TCU software version correct?</p> <ul style="list-style-type: none"> • Yes: TCU Software Version Check is complete. • No: Go to Telematics Communication Unit (TCU) Updates to update the TCU software version.

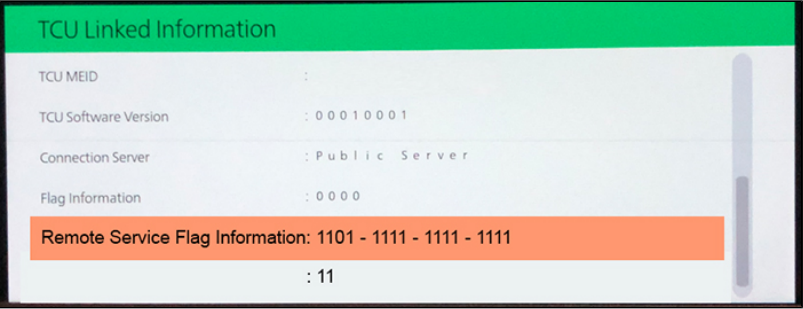
<p>4. Scroll down to Remote Service Flag Information.</p> <p>Is the Remote Service Flag Information 1101... or 0000...?</p> <ul style="list-style-type: none"> • 1101... - Disconnect 12V battery for 1 hour, then retry connected vehicle enrollment. • 0000... - Contact Hotline for technical support.
