Service Alert

Subject: CONNECTED VEHICLE SYMPTOM TROUBLESHOOTING	Service Alert No.: SA-009/23
	Last Issued : 08/28/2023

2019-2024 Mazda3
2020-2024 CX-30
2021-2024 CX-5
2021-2023 CX-9
2022-2023 MX-30
2023-2024 CX-50
2024 CX-90

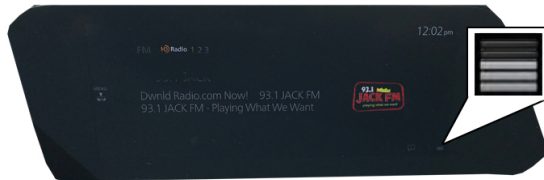
MAZDA CONNECT Indication

Radio waves are not being received. Move to a location with good reception.

Weak reception.

Good Reception

Strong reception.

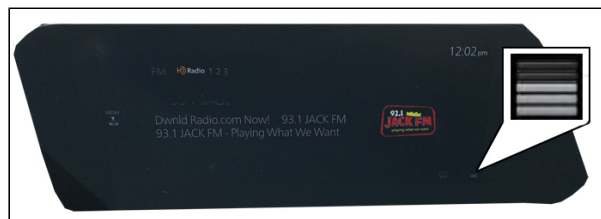
- If the reception icon shows "X", the TCU is deactivated. Enrollment is not possible. Go to [TCU Activation](#).

- If the reception icon shows "\", move the vehicle to an area with a clear view of the sky.

- If the reception is weak, move the vehicle to a location where the reception is good to strong as shown in the table, then try to get the Authorization Code and/or operate the remote functions before proceeding to the Repair Procedure if there is still an issue.
- If the reception is good to strong, proceed to Connected Vehicle Troubleshooting below.

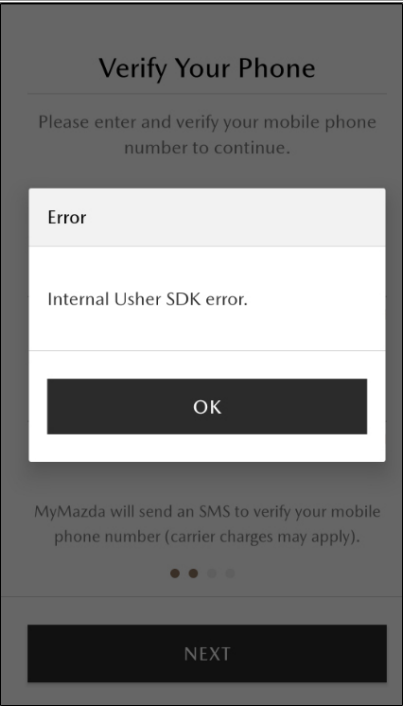
Connected Vehicle Troubleshooting			
	Symptom	Cause	Action
1	The customer is not able to create a MyMazda account. The customer receives the following error: MyMazda App - Internal Usher SDK error.	Customer inadvertently texted "Stop" to 1-949 518-0058 (Twilio SMS for Mazda)	1. Text "Start" to 1-949 518-0058 (Twilio SMS for Mazda) 2. Retry to create a MyMazda account. NOTE: USA and Canada only

<p>Verify Your Phone</p> <p>Please enter and verify your mobile phone number to continue.</p> <p>Error</p> <p>Internal Usher SDK error.</p> <p>OK</p> <p>MyMazda will send an SMS to verify your mobile phone number (carrier charges may apply).</p> <p>NEXT</p> <p>MyMazda Website - ERROR! Unable to send one-time password.</p>

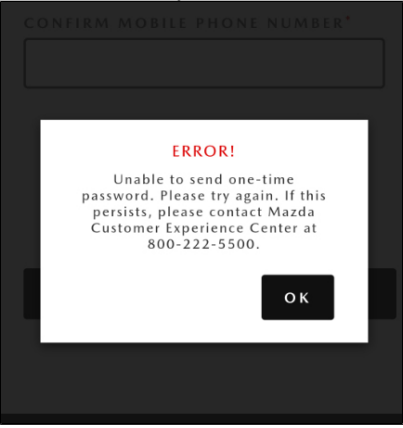
<p>CONFIRM MOBILE PHONE NUMBER</p> <p>ERROR!</p> <p>Unable to send one-time password. Please try again. If this persists, please contact Mazda Customer Experience Center at 800-222-5500.</p> <p>OK</p>		
<p>2</p> <p>Remote function(s) inoperative.</p> <ul style="list-style-type: none"> • Engine Start / Stop • Door Lock / Unlock • Lights ON / OFF 	<p>Go to the MyMazda App to view the reason for remote function failure.</p>	<p>Push Notification</p>

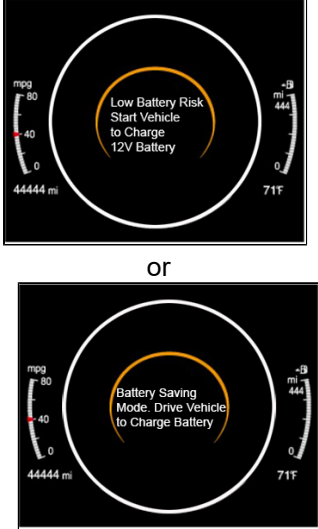
8	<p>2021 Mazda3, CX-30, CX-50, and MX-30 functions inoperative</p> <ul style="list-style-type: none"> • Vehicle Status Alert • Remote Engine Start / Stop • Remote Door Lock / Unlock • Remote Hazard Lights ON / OFF • Vehicle Finder (vehicle location mapping function is available) 	<p>Vehicle's electrical control area network (CAN) is in "Sleep Mode"</p>

<p>OR</p> <p>No dealer visit is required. Sleep Mode can be reset by starting the engine and idling or driving for 5 minutes or longer.</p> <p>Go to 09-010/22.</p>
9	<p>First remote control attempt fails, second attempt works fine.</p> <ul style="list-style-type: none"> • Engine Start / Stop • Door Lock / Unlock • Lights ON / OFF 	<p>Improper telematics communication unit (TCU) software.</p>	<p>Go to TSB 16-002/20.</p>
10	<p>Engine turns off when customer opens vehicle door.</p>	<p>Normal Operation</p>	<p>Advise that, for customer's safety and security, vehicle is designed to shut-off automatically when the vehicle door is opened.</p>

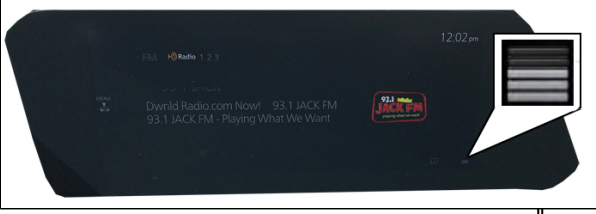
<ul style="list-style-type: none"> Reception strength icon shows normal strength. TCU is now active. Proceed to Enrollment.

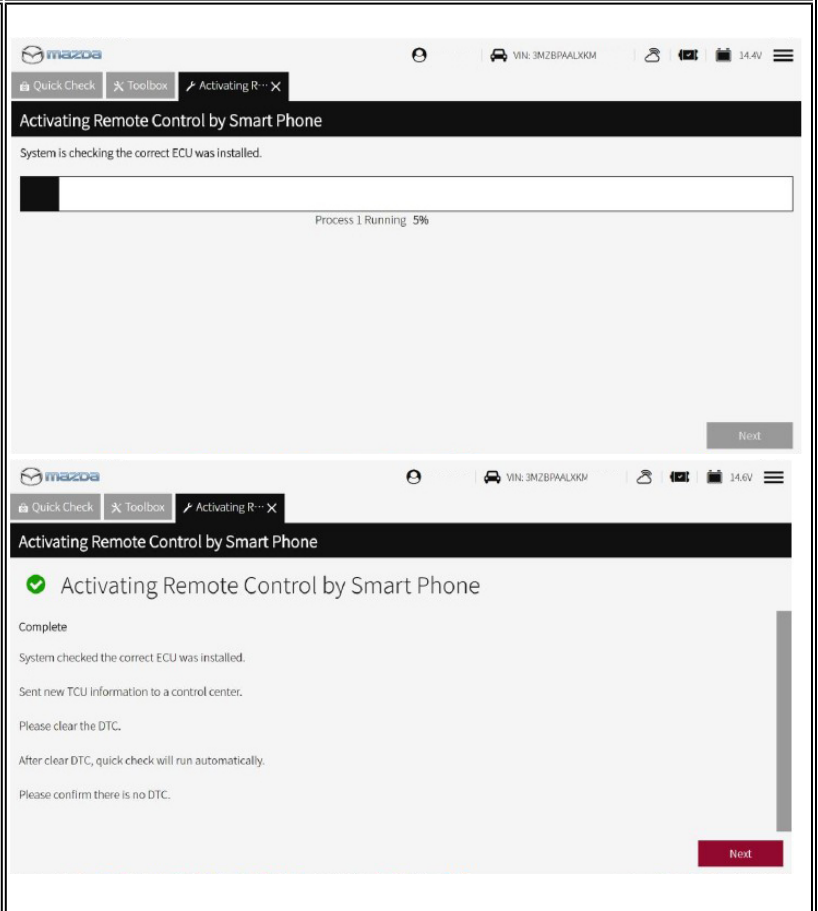
NOTE: If the Activating Remote Control by Smart Phone shows "Incomplete", the possible causes are:

- a. The advanced key is not in the vehicle.
- b. The connected Vehicle Maintenance Mode is enabled.
- c. The Key transmitter power saving function is enabled.
- d. The pacemaker radio wave interference prevention function is enabled.

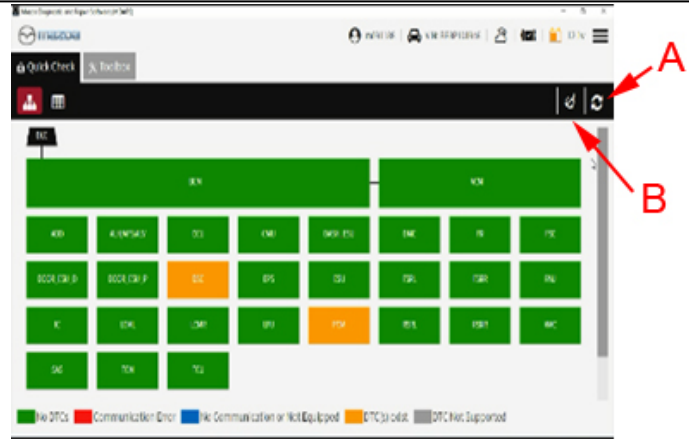
CAUTION: If the engine is not started, DTC P2610 is stored and cannot be erased.

5. Select Quick Check (A), then start the engine and select the DTC Clear icon (B).

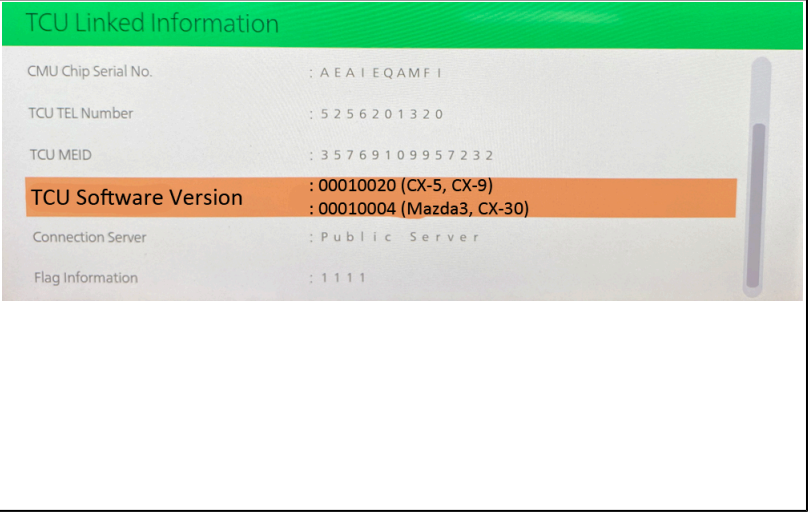
Is the TCU software version correct?

- **Yes:** TCU Software Version Check is complete.
- **No:** Go to [Telematics Communication Unit \(TCU\) Updates](#) to update the TCU software version.

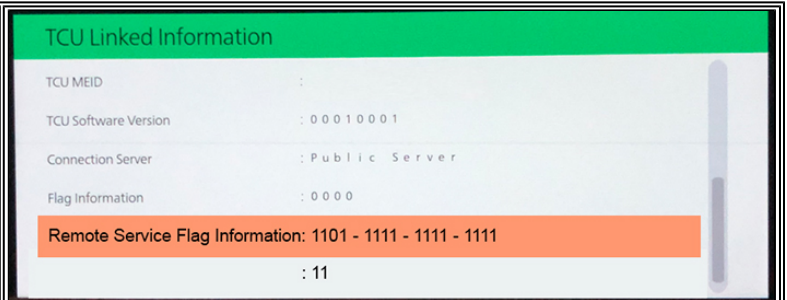
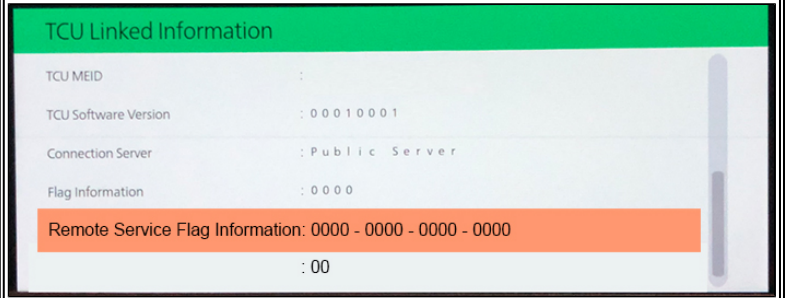
Is the Remote Service Flag Information 1101... or 0000...?

- **1101...** - Disconnect 12V battery for 1 hour, then retry connected vehicle enrollment.
- **0000...** - Contact Hotline for technical support.
