HYUNDAI Technical Service Bulletin	GROUP AUTOMATIC TRANSMISSION	NUMBER 23-AT-006H-1
	DATE AUGUST 2023	MODEL PALISADE (LX2) SANTA FE (TMA) SANTA FE HYBRID (TM/TMa HEV) SONATA (DN8A) SONATA HYBRID (DN8 HEV) TUCSON (NX4/NX4A) TUCSON HYBRID (NX4 HEV)
SUBJECT: AUTOMATIC TRANSAXLE PUSH-BUTTON SHIFTER DIAGNOSIS

This TSB supersedes TSB 23-AT-006H to add an additional applicable model, an additional diagnostic trouble code (DTC) P0706, and modify the service procedure on step 6.**

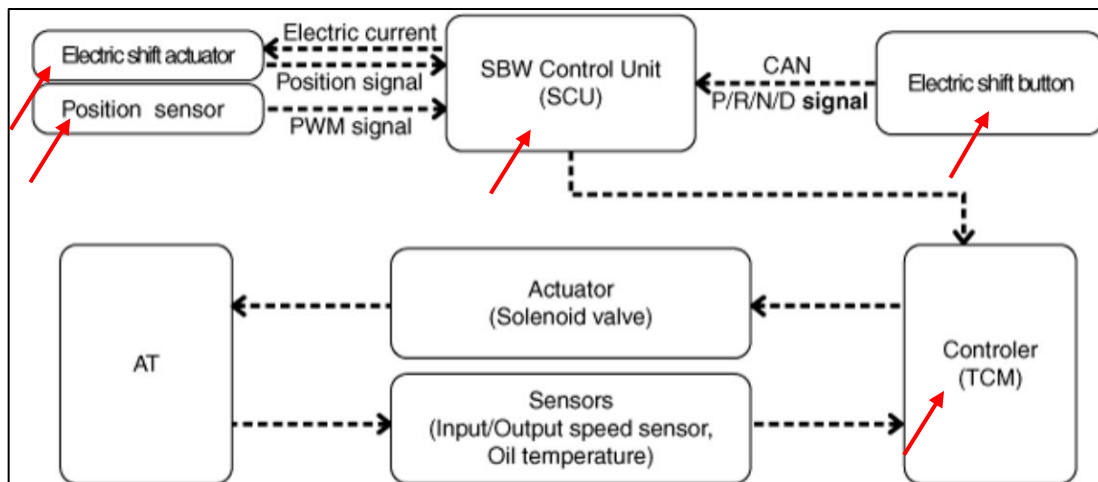
4 components are required to shift to P, R, N and D.

In addition, the PCM or TCU are required to select the correct transmission solenoids.
