## SERVICE BULLETIN

**APPLICABILITY:** 2017-23MY Impreza  
 2018-23MY Crosstrek  
 2019-23MY Forester  
 2022MY WRX

**NUMBER:** 07-221-23  
**DATE:** 08/31/23

**SUBJECT:** Instrument Panel Wiring Harness & Rear Wiring Harness – Connector Corrosion

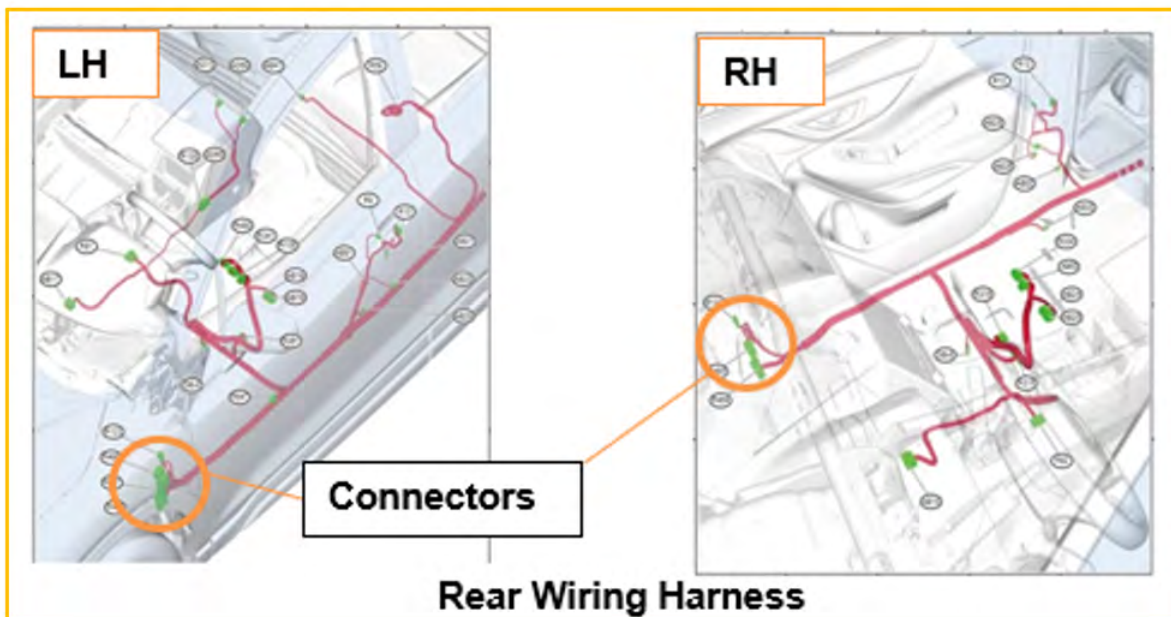
**WIRING HARNESS DETAIL INFORMATION:**

This bulletin announces the repair procedures when corrosion is encountered within the instrument panel wiring harness and the rear wiring harness connectors. The corrosion is typically found in the footwell area as a result from moisture such as rain, snow, ice, and salt water being brought in from driver and/or passenger footwear. Corrosion in this area can cause multiple electrical malfunctions such as warning indicators and/or incorrect door position detection. If corrosion is found within this area(s), replace the affected wiring harness and perform the added procedure detailed below using the new repair kit. The purpose of the repair kit is to isolate the connections from any moisture damage.

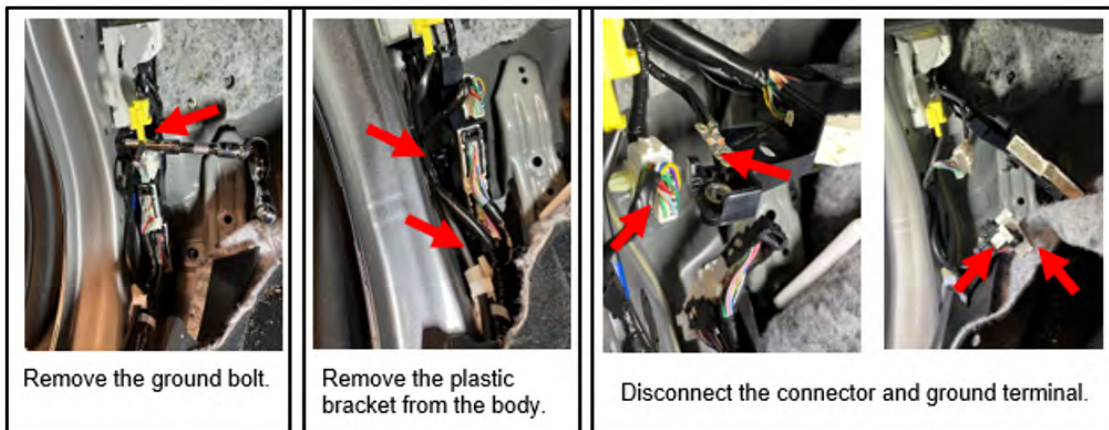
**IMPORTANT:** When replacing the instrument panel wiring harness, rear wiring harness, or left front door cord harness, take special care when handling the ground terminal.

**STEP 2:** Replace the affected wiring harness. The service procedures for instrument panel, left front door cord, and the rear harnesses remain unchanged. Always refer to the applicable Service Manual and review the full requirements of the repair being performed. The Service Manual procedures contain information critical to performing an effective repair the first time, every time. This includes but is not limited to important SAFETY precautions, proper inspection criteria, necessary special tools, required processes and related one-time-use parts needed for a complete and lasting repair.
