Technical Service Bulletin

GROUP AUTOMATIC TRANSMISSION	NUMBER 23-AT-013H
DATE AUGUST 2023	MODEL(S) VELOSTER N (JSN) KONA N (OSN) ELANTRA N (CN7N)

SUBJECT: 8-SPEED WET DCT TCU UPGRADE – TOUCH POINT LEARNING IMPROVEMENT FOR 2.0T VEHICLES

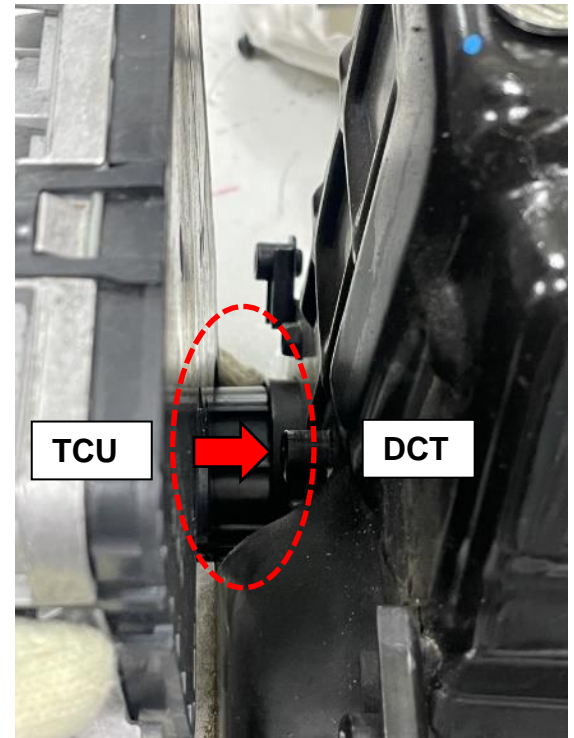
Female terminal of E-module (on DCT)

Make sure the TCU 24-pin terminal is aligned properly during removal/installation, otherwise the pins may get damaged.

2. When reinstalling the TCU, make sure to align the connector on the TCU to the E-module on the DCT.
