Subject: REVISION: N222375790-07 - Customer Satisfaction Program
Park Assist Retrofit
Warranty Information Table Improvements

Models: 2022 – 2023 Buick Envision
2022 – 2023 Cadillac CT4
2022 – 2023 Cadillac CT5
2022 Cadillac Escalade/Escalade ESV
2022 – 2023 Chevrolet Corvette
2022 Chevrolet Silverado 1500 New
2022 Chevrolet Suburban
2022 Chevrolet Tahoe
2022 GMC Sierra 1500 New
2022 GMC Yukon/Yukon XL

N222375790 Park Assist Retrofit

Revision: 07

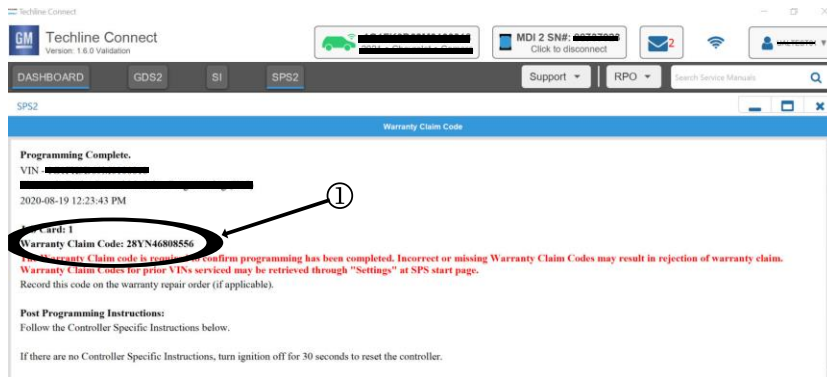
5644478

Note: The screenshot above is an example of module programming and may not be indicative of the specific module that is being programmed. Module selection and VIN information have been blacked out.
