GLOBAL SAFETY FIELD INVESTIGATIONS DCS6666 URGENT - DISTRIBUTE IMMEDIATELY

Subject: REVISION: N222375791-08 - Customer Satisfaction Program

Park Assist Retrofit

N222375791 Park Assist Retrofit

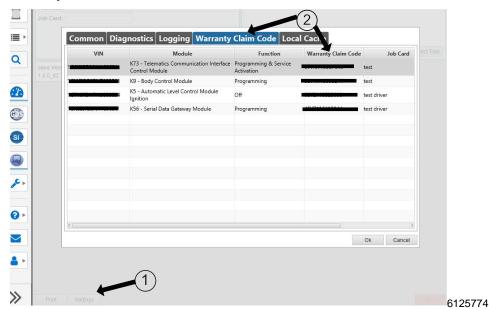
Warranty Claim Code Information Retrieval

If the Warranty Claim Code was not recorded on the Job Card, the code can be retrieved in the SPS2 system as follows:

- 1. Open TLC on the computer used to program the vehicle.
- 2. Select and start SPS2.
- 3. Select Settings (1).
- 4. Select the Warranty Claim Code tab (2).

The VIN, Warranty Claim Code and Date/Time will be listed on a roster of recent programming events. If the code is retrievable, dealers should resubmit the transaction making sure to include the code in the SPS Warranty Claim Code field.

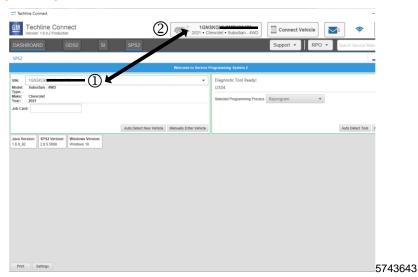
Caution: Be sure the VIN selected in the drop down menu (1) is the same as the vehicle connected (2) before beginning programming.

Important: If the vehicle VIN DOES NOT match, the message below will be shown.
