Repair Procedure MSP60 – 2023 CX-50 Door Key Lock Cylinder

**REPAIR PROCEDURE
Mazda Service Program MSP60**

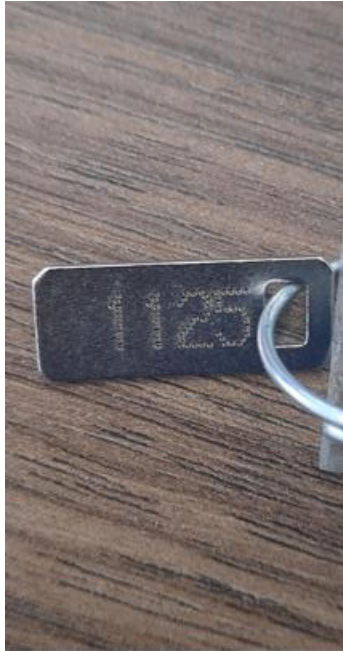
SAMPLE KEY CODE. THE KEY TAG WILL BE INCLUDED WITH THE NEW KEY LOCK CYLINDER. YOU MUST TAKE A PHOTO OF THE NEW KEY TAG AND SEND TO DEALER RECALL HELP AND ATTACH TO THE WARRANTY CLAIM.

UPDATE: To complete the repair and file a complete Warranty claim, a clear and legible photo of the NEW KEY CODE TAG MUST be sent to DEALER RECALL HELP. The photo must also be added to the warranty claim. If these steps are not completed, you will not be paid for this repair. The customer will need to return to obtain the new key code at the dealer's expense and customer inconvenience.

These steps are required so Mazda can change to the new key code in eMDCS.

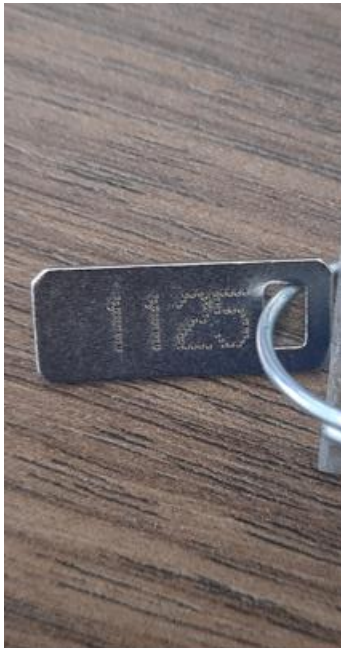
SAMPLE KEY CODE. THE KEY TAG WILL BE INCLUDED WITH THE NEW KEY LOCK CYLINDER. YOU MUST TAKE A PHOTO OF THE NEW KEY TAG AND SEND TO DEALER RECALL HELP AND ATTACH TO THE WARRANTY CLAIM.

8. Only if advised and approved by the Dealer Recall Help Team, replace the door lock with 2 new auxiliary keys (for both key FOB's) and key lock cylinder replacement. The Dealer Recall Help Team will order your new key lock part.
- a. Replace the Key Lock Cylinder following instructions in MGSS: [FRONT DOOR KEY LOCK CYLINDER REPLACEMENT.](#)
 - b. The key set comes with a new 4 or 5 digit code on the key tag.
 - c. To complete the repair and file a complete Warranty claim, a clear and legible photo of the NEW KEY CODE TAG MUST be sent to DEALER RECALL HELP. The photo must also be added to the warranty claim. If these steps are not completed, you will not be paid for this repair. The customer will need to return to obtain the new key code at the dealer's expense and customer inconvenience.

- d. Both customer key fobs will need this new key, please have the customer bring in both key fobs and discard their old auxiliary keys.
- e. Replace the new auxiliary keys in the 2 key fobs.
