Service Bulletin

Bulletin No.: 21-NA-214

Date: August, 2023

Subject: Service Engine Soon Lamp Illuminated, Harsh or Delayed Transmission Shifts Including Slip, Surge, Shudder, Noise, Whine, Growl, Shake and/or Vibration, DTCs P2002, P2463, P2459, P144E, P0421, P0422, P0106 P20EE, P129F, P16F3, P20FF, P226D, P249D, P249E, P11CC and / or P11D5 Set Current or in Recent History

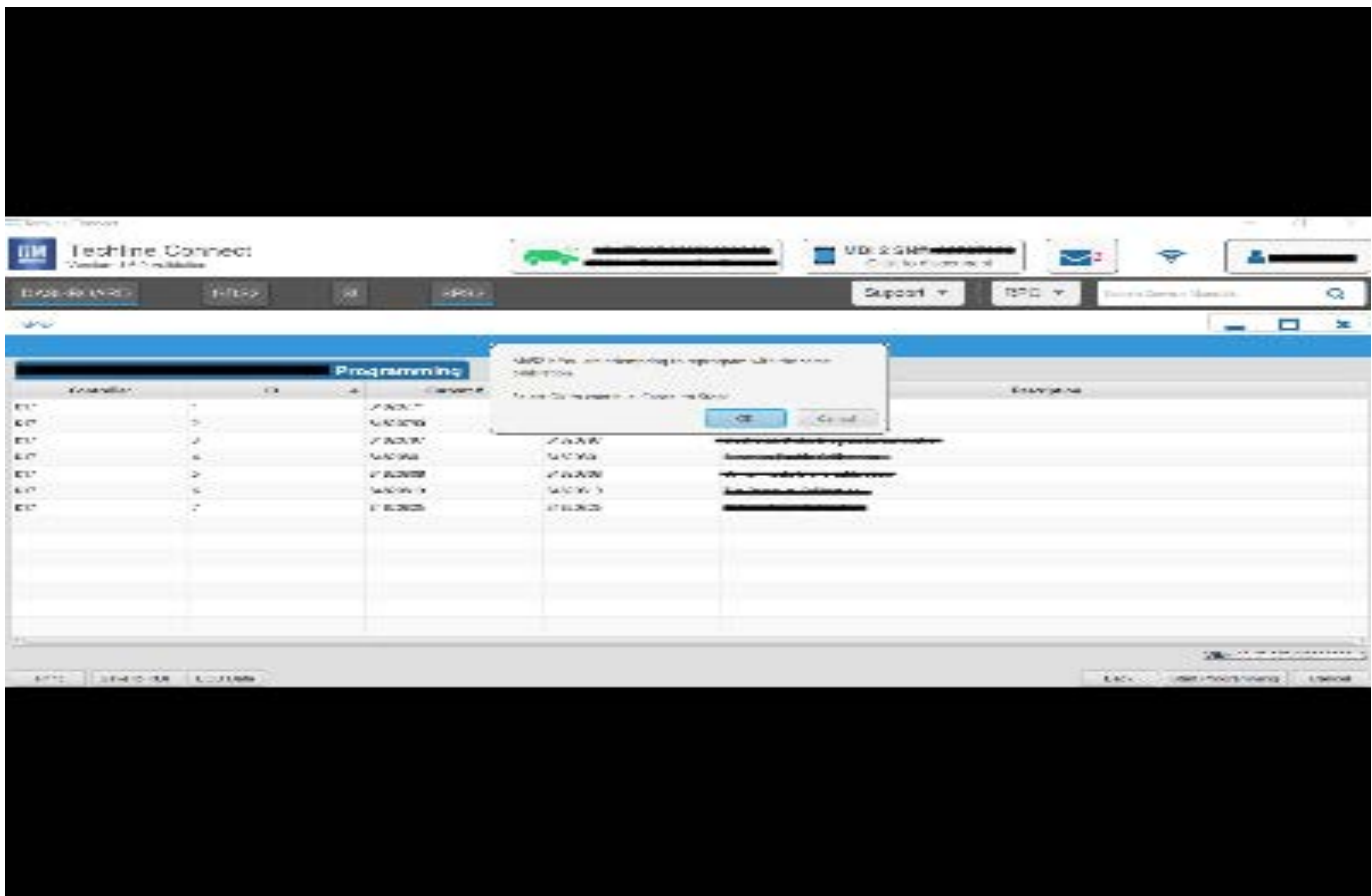
5644477

Important: Techline Connect and TIS2WEB screens shown above.

Important: If the same calibration/software warning is noted on the TLC or SPS Summary screen, select OK and follow screen instructions. After a successful programming event, the WCC is located in the Service Programming System dialogue box of the SPS Summary screen. No further action is required. Refer to the Warranty section of the bulletin.
