SIB 65 01 22

## KNEE AIR BAG CCM G01 VARIANT WIRE HARNESS REPAIR

This Service Information Bulletin (Revision 5) replaces SI B65 01 22 **dated November 2022**.

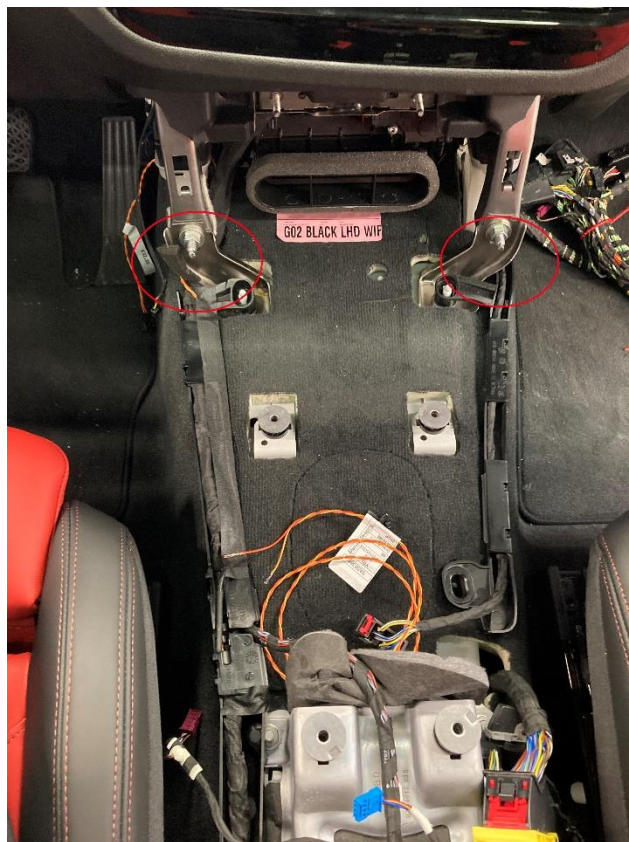
Over time, the wiring harness going to the knee air bag(s) can rub against the metal support tubes for the instrument panel, chafing and damaging the wiring.

5- Apply felt tape to the locations pictured.
