**RAPID UPDATE**

# Rapid Update 655 MC20 – AC pipe connection check

DATE: AUGUST 2 2023

Certain Maserati MC20 and MC20 Cielo(M240) MY22 MY23 listed in MODISCS+ are involved in a Rapid Update to check one of the air conditioning (AC) pipe connection nuts.

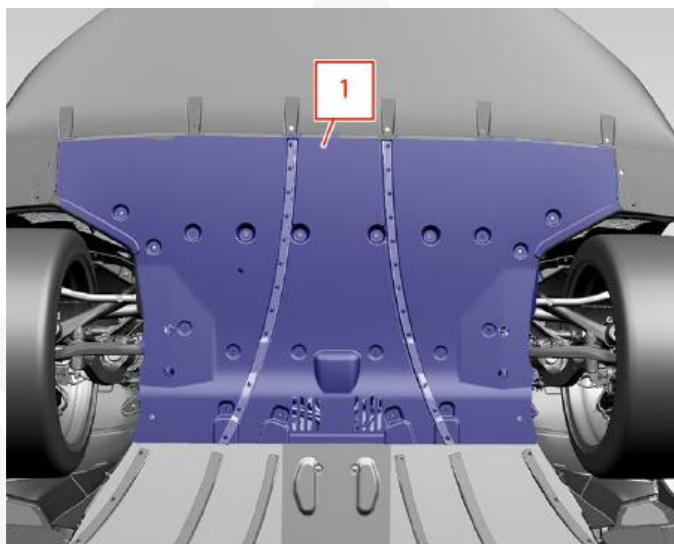
1. Always check ModisCS+ to see if the vehicle is involved in this action and if it has not been previously performed.
2. Before carrying out this operation, disconnect the 12V battery per the in the workshop manual:
  - **08.20.001 - BATTERY - Connection-disconnection of power supply**
3. Safely lift the vehicle in the air, then remove the front aerodynamic panel of the vehicle per the workshop manual:
  - **09.14.088 FRONT AERODYNAMIC COVER Removal/Refitting or Replacement**
