# Rapid Update 656

## Grecale – Air suspension system check

DATE: AUGUST 2 2023

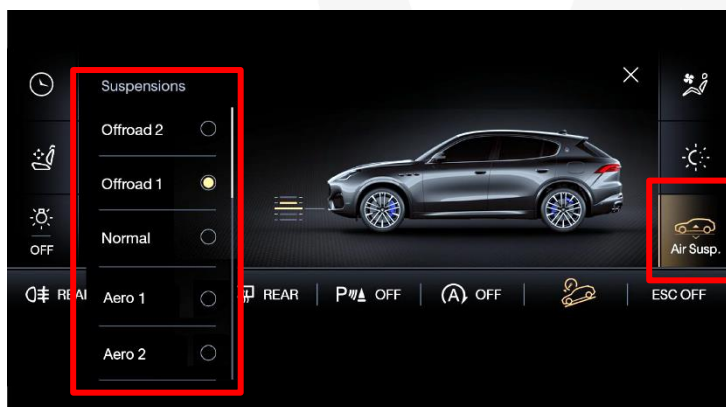
Perform 5 cycles.  
Wait 10 secs between cycles

3. Cycle from "Off Road 2" to "Aero 1" position (highest to lowest) 5 (five) times, via the "Suspension" menu in the MIA. **Wait 10 seconds between cycles to avoid overheating the system.**

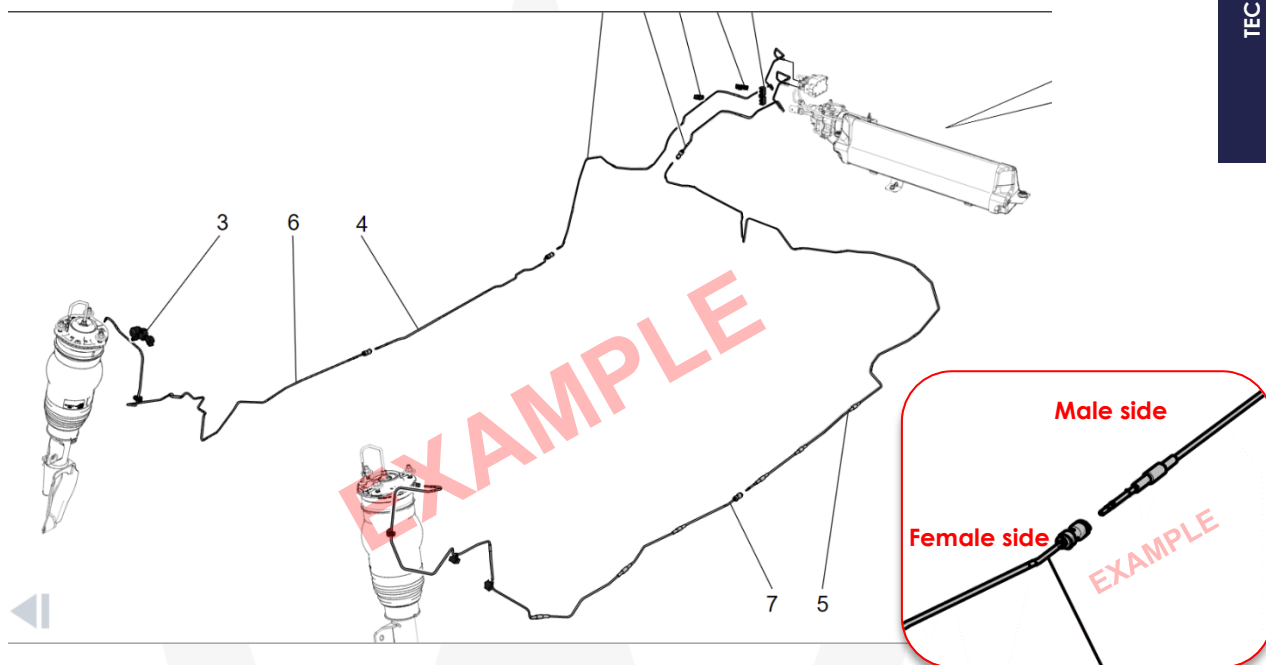
- **OK = No leaks found.** ► Open a BOL as "SUPPORT REQUEST" and report findings even if there are no obvious leaks. Attach pictures and a vehicle scan. (Vehicle scan must be in PDF format)
- **NOT OK** ► Air leak is present. Open a BOL as "SUPPORT REQUEST" and attach pictures of the leak, including a vehicle scan and report all the information collected throughout all the above checks. . (Vehicle scan must be in PDF format)

**NOTE:** If an air leak is evident from any of the areas of the air pipe couplings, it is necessary to replace the two components of the sections (male end and female ends) following the workshop procedure.
