Service Update

A232415800 Radio Module Software Update

Release Date: September 2023

Models: 2024 Buick Encore GX
2024 Chevrolet Trax
Equipped with INFOTAINMENT-VIRTUAL COCKPIT SYS - ENTRY
(RPO IVA)

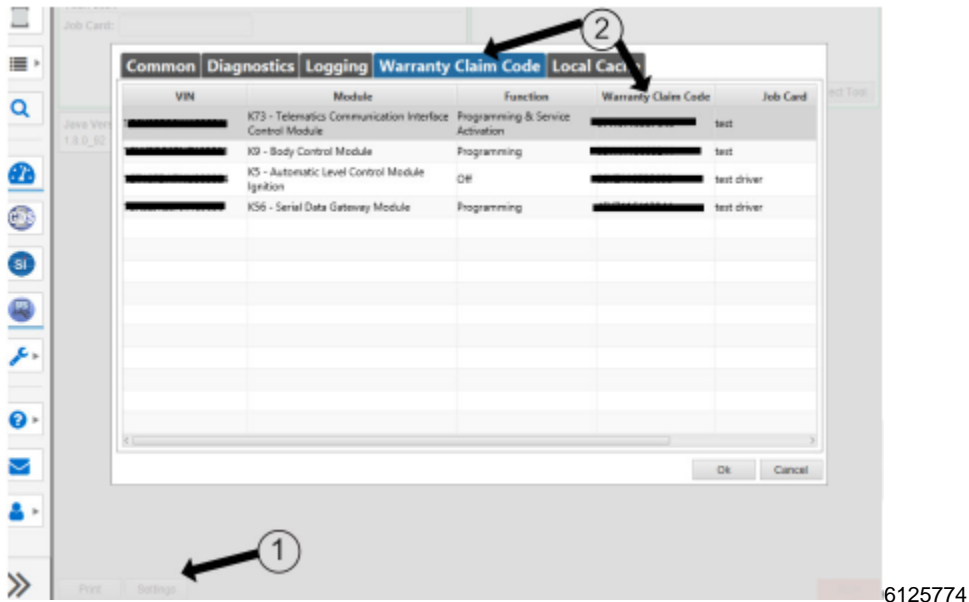
Warranty Claim Code Information Retrieval

If the Warranty Claim Code was not recorded on the Job Card, the code can be retrieved in the SPS2 system as follows:

1. Open TLC on the computer used to program the vehicle.
2. Select and start SPS2.
3. Select Settings (1).
4. Select the Warranty Claim Code tab (2).

The VIN, Warranty Claim Code and Date/Time will be listed on a roster of recent programming events. If the code is retrievable, dealers should resubmit the transaction making sure to include the code in the SPS Warranty Claim Code field.

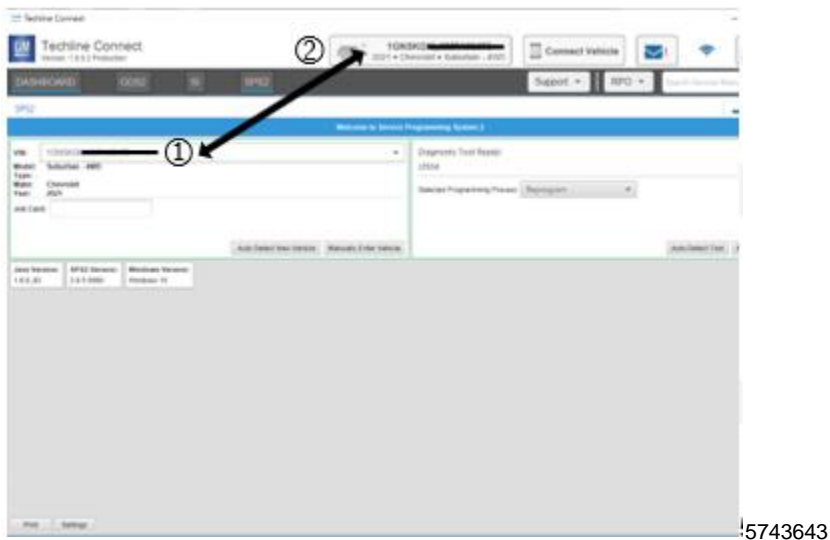
Caution: Be sure the VIN selected in the drop down menu (1) is the same as the vehicle connected (2) before beginning programming.

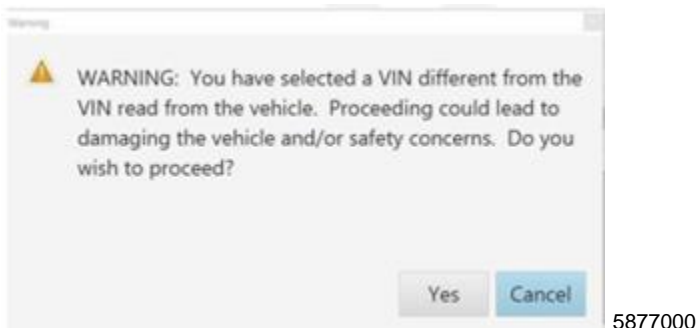
Important: If the vehicle VIN DOES NOT match, the message below will be shown.

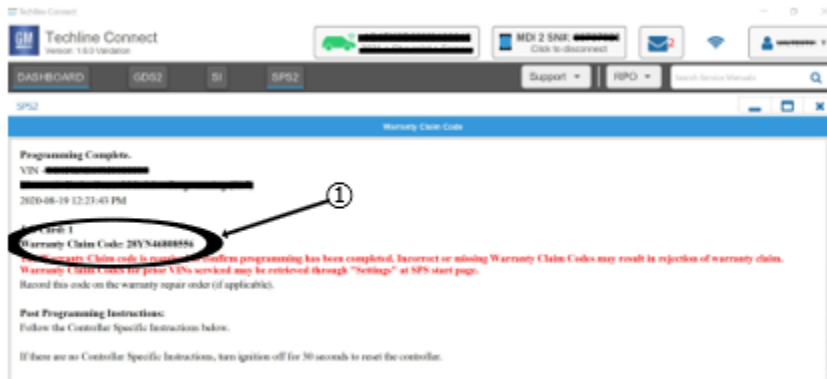
5644478

Note: The screenshot above is an example of module programming and may not be indicative of the specific module that is being programmed. Module selection and VIN information have been blacked out.
