Subject: A232415800 - Service Update
Radio Module Software Update

Models: 2024 Buick Encore GX
2024 Chevrolet Trax
Equipped with INFOTAINMENT-VIRTUAL COCKPIT SYS - ENTRY
(RPO IVA)

Service Update

A232415800 Radio Module Software Update

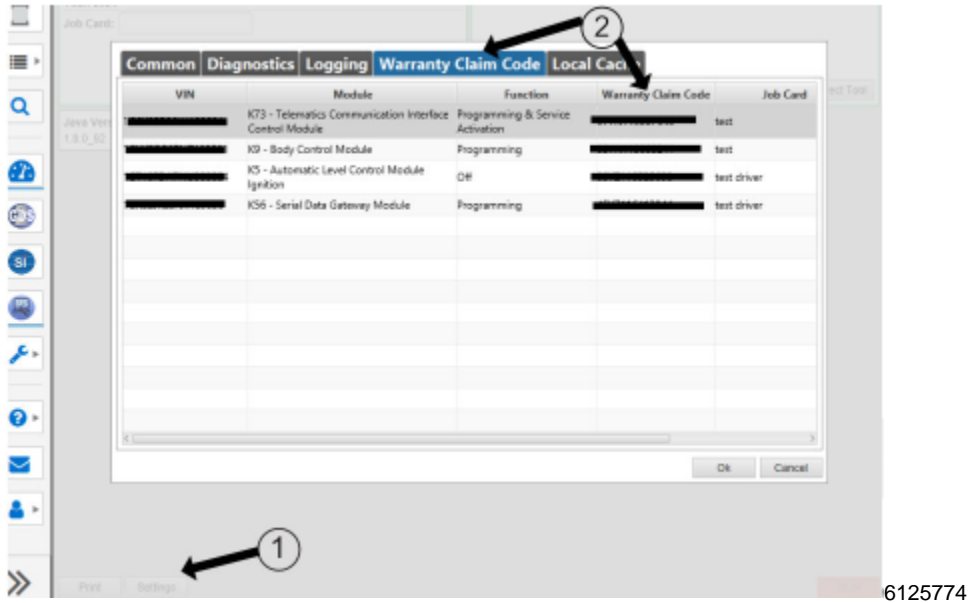
Warranty Claim Code Information Retrieval

If the Warranty Claim Code was not recorded on the Job Card, the code can be retrieved in the SPS2 system as follows:

1. Open TLC on the computer used to program the vehicle.
2. Select and start SPS2.
3. Select Settings (1).
4. Select the Warranty Claim Code tab (2).

The VIN, Warranty Claim Code and Date/Time will be listed on a roster of recent programming events. If the code is retrievable, dealers should resubmit the transaction making sure to include the code in the SPS Warranty Claim Code field.

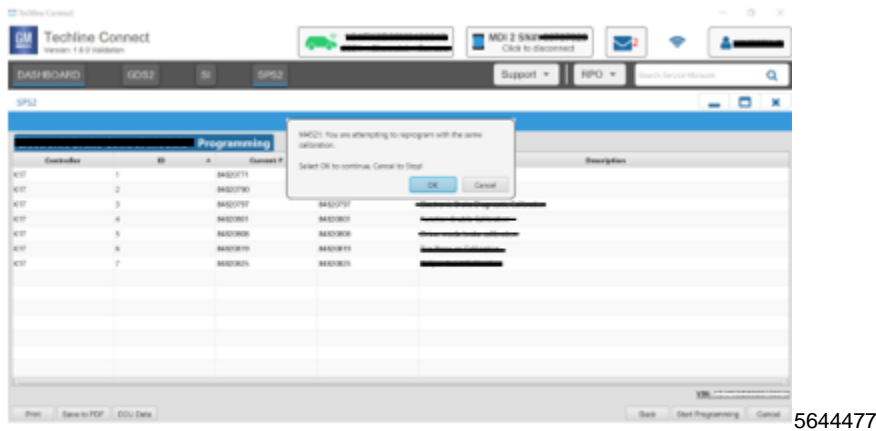
Important: Techline Connect screens shown above.

Important: If the same calibration/software warning is noted on the TLC Summary screen, select OK and follow screen instructions. After a successful programming event, the WCC is located in the Service Programming System dialogue box of the SPS Summary screen. No further action is required. Refer to the Warranty section of the bulletin.
